**NYC Department of Education
Building Condition Assessment Survey 2017 - 2018**

Architectural Inspection

K446

Asset: NEW UTRECHT AF - BROOKLYN, 1601 80 STREET, New York, 11214

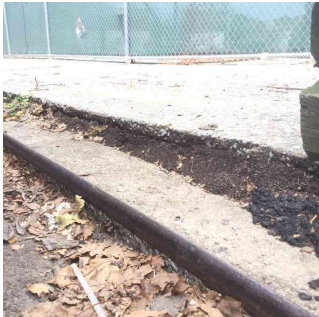
Question	Response
SITE	
Drainage System for Concrete	Does not Exist
Drainage System for Soil	Does not Exist
DRINKING FOUNTAINS	Under Construction
FENCES	Under Construction
IRRIGATION SYSTEM	Does not Exist
PAVING	Inspected
Student Non-Use	Does not Exist
Student Use	Inspected
Gravel Exists?	No
Asphalt	Does not Exist
Concrete	Under Construction
Pavers	Does not Exist
Site Sidewalks & Walkways	Inspected
Asphalt	Does not Exist
Concrete	Under Construction
Pavers	Does not Exist
DOT Sidewalk	Inspected
Asphalt	Does not Exist
Concrete	Inspected
Condition	4 - Between Fair and Poor
Deficiency	DAMAGED CURBS
Deficiency Location/Instance	80th Street
Deficiency Quantity	30
Quantity Uom	L.F.
Potential Action	REPLACE
Urgency of Action	PRIORITY 5
Purpose of Action	LEVEL 6
Deficiency Photo1	 
Violations	80th Street No violations recorded.
Deficiency	HEAVING
Deficiency Location/Instance	Along 80th Street
Deficiency Quantity	75
Quantity Uom	S.F.

Potential Action	REPLACE
Urgency of Action	PRIORITY 5
Purpose of Action	LEVEL 6

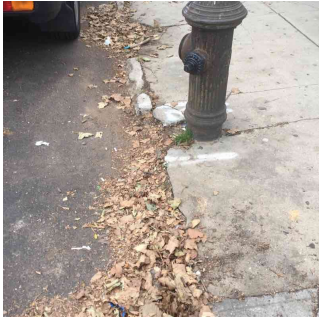
Violations	Along 80th Street No violations recorded.
Deficiency	DAMAGED CURBS
Deficiency Location/Instance	Along 79th Street, 80th Street
Deficiency Quantity	115
Quantity Uom	L.F.
Potential Action	REPLACE
Urgency of Action	PRIORITY 3
Purpose of Action	LEVEL 2
Deficiency Photo1

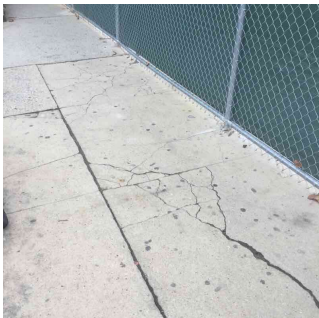
Violations	Along 80th Street No violations recorded.
Deficiency	DAMAGED/DETERIORATED/MISSING SECTIONS
Deficiency Location/Instance	Along 79th Street, 80th Street
Deficiency Quantity	1,275
Quantity Uom	S.F.
Potential Action	REPLACE
Urgency of Action	PRIORITY 3
Purpose of Action	LEVEL 2
Deficiency Photo1

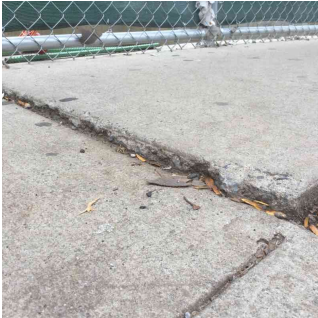
Question	Response
SITE	
PAVING	
DOT Sidewalk	
Concrete	
Violations	No violations recorded.
Deficiency	HEAVING
Deficiency Location/Instance	Along 79th Street, 80th Street
Deficiency Quantity	350
Quantity Uom	S.F.
Potential Action	REPLACE
Urgency of Action	PRIORITY 3
Purpose of Action	LEVEL 2
Deficiency Photo1
