**NYC Department of Education
Building Condition Assessment Survey 2017 - 2018**

Architectural Inspection

K555

Asset: BKLYN COLL ACAD (AT BKLYN COLL)-K, 2900 BEDFORD AVENUE, New York, 11210

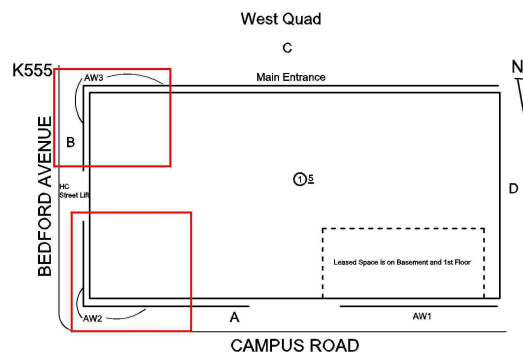
Question	Response
EXTERIOR	
AREAWAY	Inspected
Instance on AW1-AW3	Inspected
Instance Condition	3 - Fair
Instance Quantity	3
Instance Quantity Uom	EACH
Deficiency	AREAWAY WALLS: DETERIORATED JOINTS AT COPING STONES
Roof Plan reference

Deficiency Quantity	30
Quantity Uom	L.F.
Potential Action	MAINTENANCE
Urgency of Action	PRIORITY 3
Purpose of Action	LEVEL 2
Deficiency Photo1	No photo recorded
Violations	No violations recorded.
AWNINGS AND CANOPIES	Does not Exist
CHIMNEY	Not Required
COPING	Not Required
CORNICE	Does not Exist
DOORS	Inspected
DOORS AND FRAMES	Inspected
Condition	2 - Between Good and Fair
Deficiency	No deficiencies recorded
DOOR HARDWARE	Inspected
Condition	2 - Between Good and Fair
Deficiency	No deficiencies recorded
LINTELS	Inspected
Condition	2 - Between Good and Fair
Deficiency	No deficiencies recorded
TRANSOM/SIDE LIGHT	Inspected
Condition	2 - Between Good and Fair
Deficiency	No deficiencies recorded

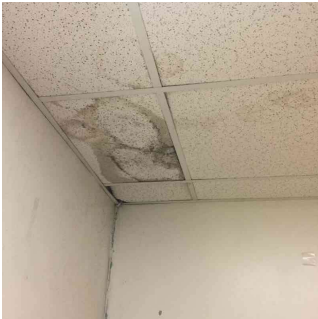
Question	Response
INTERIOR	
AUDITORIUM	Does not Exist
CAFETERIA	Does not Exist
CLASSROOMS/CORRIDORS/ADMIN SPACES	Inspected
Ceiling	Inspected
Condition	2 - Between Good and Fair
Deficiency	ACOUSTIC TILES: DAMAGED/MISSING
Deficiency Location/Instance	Rooms 0412, 0411, 0413, 0416
Deficiency Quantity	30
Quantity Uom	S.F.
Potential Action	REPLACE
Urgency of Action	PRIORITY 3
Purpose of Action	LEVEL 2
Deficiency Photo1

Room 0412
Violations	No violations recorded.
Door(s)	Inspected
Condition	5 - Poor
Deficiency	METAL: DETERIORATED DOOR
Deficiency Location/Instance	Room 0415
Deficiency Quantity	1
Quantity Uom	EACH
Potential Action	MAINTENANCE
Urgency of Action	PRIORITY 3
Purpose of Action	LEVEL 2
Deficiency Photo1

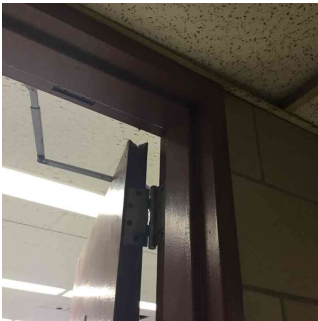
Room 0415
Violations	No violations recorded.
Deficiency	WOOD: DETERIORATED DOOR
Deficiency Location/Instance	Rooms 0401, 0414
Deficiency Quantity	2
Quantity Uom	EACH
Potential Action	MAINTENANCE
Urgency of Action	PRIORITY 3
