NYC Department of Education
Building Condition Assessment Survey 2017 - 2018

Architectural Inspection

Asset: **PRE-K CENTER @ 1139 CONEY ISLAND AVENUE - BROOKLYN, 1139 CONEY ISLAND AVENUE, New York, 11230**

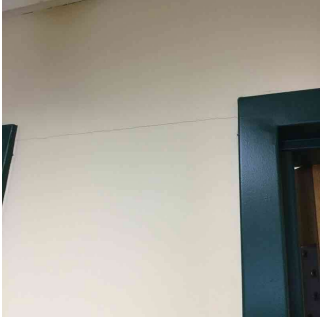
Question	Response
INTERIOR	
CLASSROOMS/CORRIDORS/ADMIN SPACES	
Ceiling	Inspected
Deficiency	No deficiencies recorded
Door(s)	Inspected
Condition	1 - Good
Deficiency	No deficiencies recorded
Floor Finish	Inspected
Condition	1 - Good
Deficiency	No deficiencies recorded
Walls	Inspected
Condition	2 - Between Good and Fair
Deficiency	GYP SUM BOARD: DETERIORATED
Deficiency Location/Instance	Corridor near Rooms 209, 213
Deficiency Quantity	15
Quantity Uom	S.F.
Potential Action	REPLACE
Urgency of Action	PRIORITY 3
Purpose of Action	LEVEL 2
Deficiency Photo1

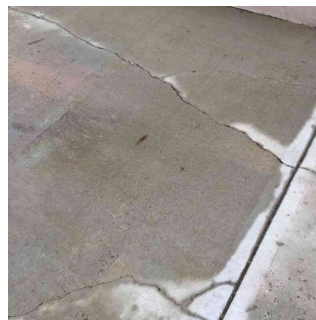
Condition	3 - Fair
Deficiency	CRACKS - MAJOR
Deficiency Location/Instance	Schoolyard
Deficiency Quantity	200
Quantity Uom	S.F.
Potential Action	REPLACE
Urgency of Action	PRIORITY 3
Purpose of Action	LEVEL 2
Deficiency Photo1

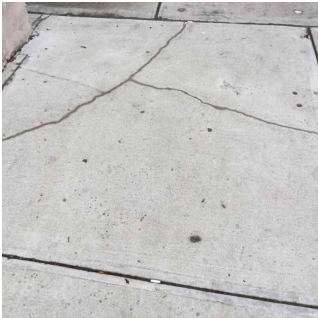
Question	Response
SITE	
PAVING	
Student Use	Inspected
Concrete	Inspected
Violations	Schoolyard No violations recorded.
Pavers	Does not Exist
Site Sidewalks & Walkways	Inspected
Asphalt	Does not Exist
Concrete	Inspected
Condition	2 - Between Good and Fair
Deficiency	No deficiencies recorded
Pavers	Does not Exist
DOT Sidewalk	Inspected
Asphalt	Does not Exist
Concrete	Inspected
Condition	3 - Fair
Deficiency	DAMAGED/DETERIORATED/MISSING SECTIONS
Deficiency Location/Instance	Coney Island Avenue, Avenue H
Deficiency Quantity	175
Quantity Uom	S.F.
Potential Action	REPLACE
Urgency of Action	PRIORITY 3
Purpose of Action	LEVEL 2
Deficiency Photo1

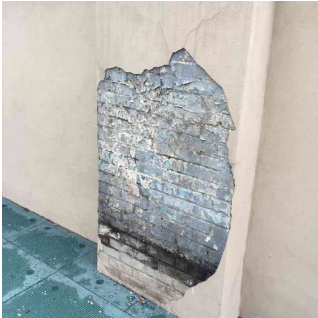
Schoolyard
Violations	No violations recorded.
STAIRS/RAMPS: EXTERIOR	Does not Exist

Question	Response
SITE	
PLAYGROUNDS	
Safety Surfacing	
Instance on Schoolyard	Inspected
Condition	1 - Good
Deficiency	No deficiencies recorded
Unpaved Area	
Instance on Schoolyard	Does not Exist
PLAYING SURFACE	Does not Exist
RETAINING WALLS	Does not Exist
SEATING	Inspected
Benches	Inspected
Concrete	Does not Exist
Metal/Wood/Plastic	Inspected
Condition	1 - Good
Deficiency	No deficiencies recorded
Bleachers	Does not Exist
SITE WALLS (NOT RETAINING WALLS)	Inspected
Condition	3 - Fair
Deficiency	CAST IN PLACE CONCRETE: CRACKS/SPALLING - MAJOR
Deficiency Location/Instance	Schoolyard
Deficiency Quantity	135
Quantity Uom	S.F.
Potential Action	REPLACE
Urgency of Action	PRIORITY 3
Purpose of Action	LEVEL 2
Deficiency Photo1
