**NYC Department of Education
Building Condition Assessment Survey 2017 - 2018**

Architectural Inspection

K921

Asset: P.S. 179 TRANSPORTABLE - K, 202 AVENUE C, New York, 11218

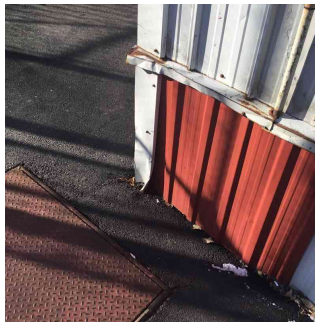
Facade B

Question	Response
EXTERIOR	
DOORS	
DOOR HARDWARE	
Condition	3 - Fair
Deficiency	No deficiencies recorded
EXTERIOR WALLS	Inspected
Material Type(s)	Steel
Replacement Quantity	5,800
Replacement Uom	S.F.
Instance on All Facades	Inspected
Instance Condition	4 - Between Fair and Poor
Instance Quantity	5,800
Instance Quantity Uom	S.F.
Deficiency	METAL PANEL: DAMAGED TRIM
Roof Plan reference	<p align="center">K921</p>
Elevation	
Deficiency Quantity	5
Quantity Uom	L.F.
Potential Action	REPLACE
Urgency of Action	PRIORITY 4
Purpose of Action	LEVEL 2
Deficiency Photo1	
Violations	Facade K No violations recorded.
Deficiency	METAL PANEL: SEVERE DENTS

REPLACE

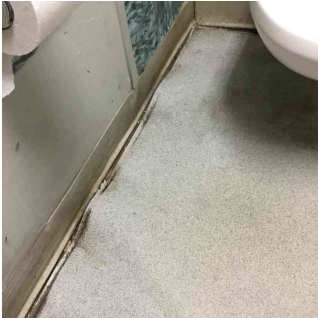
Question	Response
INTERIOR	
TOILET ROOMS - STUDENTS	
Door(s)	Inspected
Condition	2 - Between Good and Fair
Deficiency	No deficiencies recorded
Floor Finish	Inspected
Condition	2 - Between Good and Fair
Deficiency	VINYL TILES: BROKEN/DETERIORATED/MISSING TILES
Deficiency Location/Instance	Room T/3
Deficiency Quantity	30
Quantity Uom	S.F.
Potential Action	REPLACE
Urgency of Action	PRIORITY 3
Purpose of Action	LEVEL 2
Deficiency Photo1

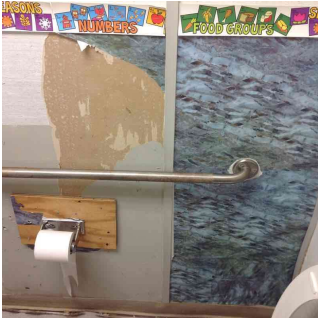
Inside Room T3
Violations	No violations recorded.
SITE	Not Required

Room T3
Violations	No violations recorded.
Walls	Inspected
Condition	2 - Between Good and Fair
Deficiency	GYPSUM BOARD: DETERIORATED
Deficiency Location/Instance	Inside Room T3
Deficiency Quantity	10
Quantity Uom	S.F.
Potential Action	REPLACE
Urgency of Action	PRIORITY 3
Purpose of Action	LEVEL 2
Deficiency Photo1
