**NYC Department of Education  
Building Condition Assessment Survey 2017 - 2018**

Architectural Inspection

**K958**

**Asset: P.S. 202 TRANSPORTABLE - K, 982 HEGEMAN AVENUE, New York, 11208**

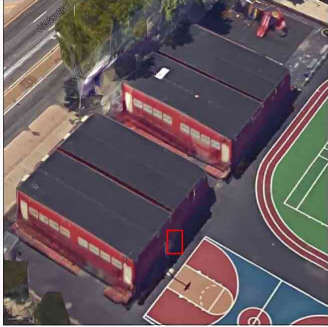
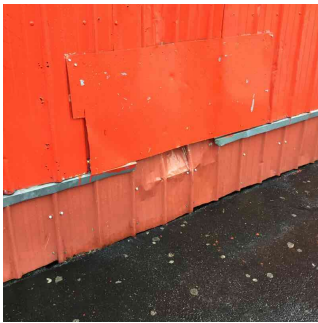
Question	Response
<b>Architectural</b>	
<b>EXTERIOR</b>	Inspected
<b>AWNINGS AND CANOPIES</b>	Does not Exist
<b>DOORS</b>	Inspected
<b>DOORS AND FRAMES</b>	Inspected
Condition	2 - Between Good and Fair
Deficiency	No deficiencies recorded
<b>DOOR HARDWARE</b>	Inspected
Condition	3 - Fair
Deficiency	No deficiencies recorded
<b>EXTERIOR WALLS</b>	Inspected
Material Type(s)	Steel
Replacement Quantity	5,400
Replacement Uom	S.F.
Instance on All Facades	Inspected
Instance Condition	3 - Fair
Instance Quantity	5,400
Instance Quantity Uom	S.F.
Deficiency	METAL PANEL: SEVERE DENTS

Deficiency Quantity	50
Quantity Uom	S.F.
Potential Action	REPLACE
Urgency of Action	PRIORITY 4
Purpose of Action	LEVEL 2
Deficiency Photo1

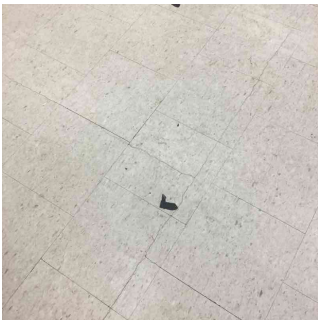
Question	Response
<b>INTERIOR</b>	
<b>STRUCTURAL</b>	
<b>FLOOR STRUCTURE</b>	Inspected
Condition	2 - Between Good and Fair
Deficiency	No deficiencies recorded
<b>ROOF STRUCTURE</b>	Inspected
Condition	2 - Between Good and Fair
Deficiency	No deficiencies recorded
<b>CAFETERIA</b>	Does not Exist
<b>CLASSROOMS/CORRIDORS/ADMIN SPACES</b>	Inspected
<b>Ceiling</b>	Inspected
Condition	2 - Between Good and Fair
Deficiency	No deficiencies recorded
<b>Door(s)</b>	Inspected
Condition	1 - Good
Deficiency	No deficiencies recorded
<b>Floor Finish</b>	Inspected
Condition	5 - Poor
Deficiency	VINYL TILES; DETERIORATED SUBSTRATE
Deficiency Location/Instance	Rooms T1-6
Deficiency Quantity	600
Quantity Uom	S.F.
Potential Action	REPLACE
Urgency of Action	PRIORITY 3
Purpose of Action	LEVEL 2
Deficiency Photo1
