**NYC Department of Education
Building Condition Assessment Survey 2018 - 2019**

Architectural Inspection

Asset: P.S. 261 TRANSPORTABLE - K, 314 PACIFIC STREET, New York, 11210

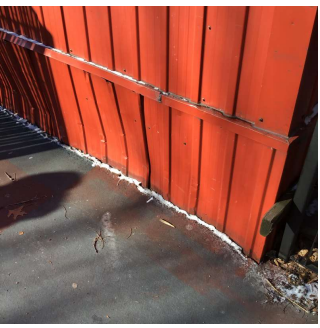
Question	Response
Architectural	
EXTERIOR	Inspected
AWNINGS AND CANOPIES	Inspected
Condition	2 - Between Good and Fair
Deficiency	No deficiencies recorded
DOORS	Inspected
DOORS AND FRAMES	Inspected
Condition	2 - Between Good and Fair
Deficiency	No deficiencies recorded
DOOR HARDWARE	Inspected
Condition	3 - Fair
Deficiency	No deficiencies recorded
EXTERIOR WALLS	Inspected
Material Type(s)	Steel
Replacement Quantity	1,500
Replacement Uom	S.F.
Instance on All Facades	Inspected
Instance Condition	5 - Poor
Instance Quantity	1,500
Instance Quantity Uom	S.F.
Deficiency	METAL PANEL: SEVERE DENTS

Deficiency Quantity	80
Quantity Uom	S.F.
Potential Action	REPLACE
Urgency of Action	PRIORITY 4
Purpose of Action	LEVEL 2
Deficiency Photo1

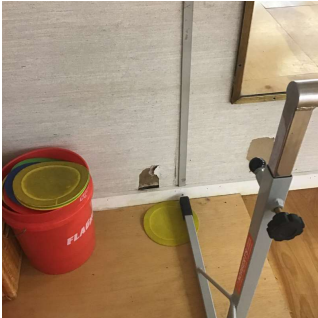
Question	Response
INTERIOR	
CLASSROOMS/CORRIDORS/ADMIN SPACES	
Walls	
Deficiency	GYP SUM BOARD: DETERIORATED
Deficiency Location/Instance	Right Side
Deficiency Quantity	10
Quantity Uom	S.F.
Potential Action	REPLACE
Urgency of Action	PRIORITY 3
Purpose of Action	LEVEL 2
Deficiency Photo1
