NYC Department of Education
Building Condition Assessment Survey 2017 - 2018

Architectural Inspection

K986

Asset: DIV. OF INSTR. & INFO. TECH.-K, 335 ADAMS STREET, New York, 11201

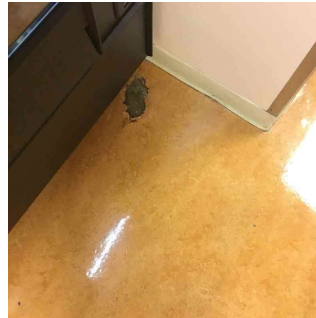
SHEET VINYL: BROKEN/DETERIORATED

Corridor Near 28th Floor Fan Room, 28th Floor Pantry Area

REPLACE

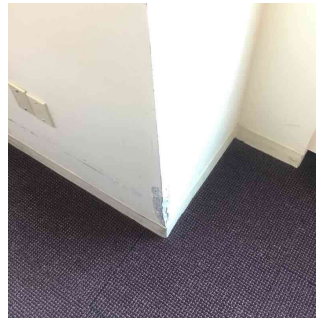
GYPSON BOARD: DETERIORATED

28th Floor- West

REPLACE

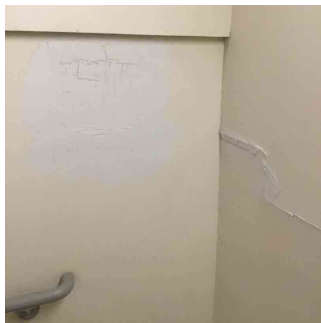
Condition	2 - Between Good and Fair
Deficiency	No deficiencies recorded
Walls	Inspected
Condition	2 - Between Good and Fair
Deficiency	GYPSUM BOARD: DETERIORATED
Deficiency Location/Instance	Stairs A/28, B/29
Deficiency Quantity	20
Quantity Uom	S.F.
Potential Action	REPLACE
Urgency of Action	PRIORITY 3
Purpose of Action	LEVEL 2

Violations	Stair B/29 No violations recorded.
TOILET ROOMS - STAFF	Inspected
Ceiling	Inspected
Condition	3 - Fair
Deficiency	ACOUSTIC TILES: DAMAGED/MISSING
Deficiency Location/Instance	5th Floor Men's, 28th Floor Women's, 29th Floor Men's
Deficiency Quantity	25
Quantity Uom	S.F.
Potential Action	REPLACE
Urgency of Action	PRIORITY 3
Purpose of Action	LEVEL 2
Deficiency Photo1
