**NYC Department of Education
Building Condition Assessment Survey 2018 - 2019**

Architectural Inspection

K990

Asset: PAVE ACADEMY CHARTER SCHOOL - BROOKLYN, 732 HENRY STREET, New York, 11231

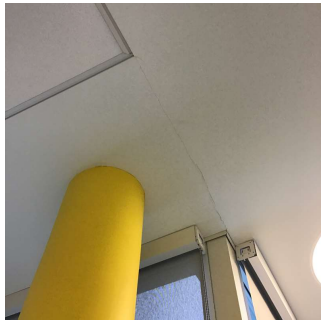
Question	Response
INTERIOR	
CAFETERIA	
Instance on 1st Floor	Inspected
Ceiling	
Instance on 1st Floor	Inspected
Condition	2 - Between Good and Fair
Deficiency	No deficiencies recorded
Door(s)	
Instance on 1st Floor	Inspected
Condition	2 - Between Good and Fair
Deficiency	No deficiencies recorded
Fixed Equipment	
Instance on 1st Floor	Does not Exist
Floor Finish	
Instance on 1st Floor	Inspected
Condition	2 - Between Good and Fair
Deficiency	No deficiencies recorded
Sliding-folding Partition	
Instance on 1st Floor	Does not Exist
Stage	
Instance on 1st Floor	Does not Exist
Walls	
Instance on 1st Floor	Inspected
Condition	2 - Between Good and Fair
Deficiency	No deficiencies recorded
Window Curtains/Shades/Blinds	
Instance on 1st Floor	Does not Exist
CLASSROOMS/CORRIDORS/ADMIN SPACES	
	Inspected
Ceiling	
Condition	2 - Between Good and Fair
Deficiency	GYPSUM BOARD: DAMAGED/DETERIORATED
Deficiency Location/Instance	Corridor near Room 215

Deficiency Quantity	10
Quantity Uom	S.F.
Potential Action	REPLACE
Urgency of Action	PRIORITY 3
Purpose of Action	LEVEL 2
Deficiency Photo1

Corridor near Room 215
Violations	No violations recorded.
Door(s)	
Condition	2 - Between Good and Fair

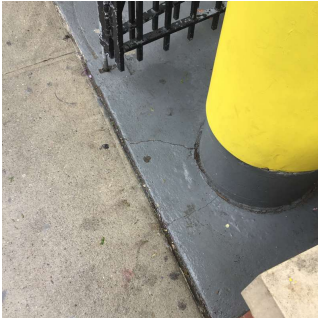
Question	Response
SITE	
FENCES	Inspected
Deficiency	No deficiencies recorded
IRRIGATION SYSTEM	Does not Exist
PAVING	Inspected
Student Non-Use	Does not Exist
Student Use	Inspected
Gravel Exists?	No
Asphalt	Does not Exist
Concrete	Does not Exist
Pavers	Inspected
Condition	2 - Between Good and Fair
Deficiency	No deficiencies recorded
Site Sidewalks & Walkways	Inspected
Asphalt	Does not Exist
Concrete	Inspected
Condition	2 - Between Good and Fair
Deficiency	DAMAGED/DETERIORATED/MISSING SECTIONS
Deficiency Location/Instance	Main Entrance on Mill Street
Deficiency Quantity	25
Quantity Uom	S.F.
Potential Action	REPLACE
Urgency of Action	PRIORITY 3
Purpose of Action	LEVEL 2
Deficiency Photo1

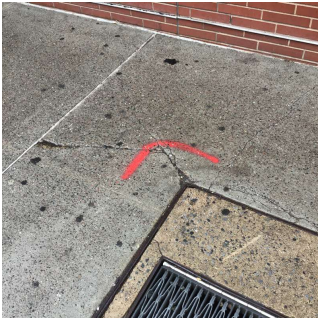
Violations	No violations recorded.
Pavers	Does not Exist
DOT Sidewalk	Inspected
Asphalt	Does not Exist
Concrete	Inspected
Condition	3 - Fair
Deficiency	DAMAGED/DETERIORATED/MISSING SECTIONS
Deficiency Location/Instance	Henry Street, Mill Street

Deficiency Quantity	150
Quantity Uom	S.F.
Potential Action	REPLACE
Urgency of Action	PRIORITY 3
Purpose of Action	LEVEL 2

Question	Response
SITE	
PAVING	Inspected
DOT Sidewalk	
Concrete	
Deficiency Photo1

Violations	Mill Street No violations recorded.
Pavers	Does not Exist
PLAYGROUNDS	Inspected
Instance on Corner of Mill and Henry Streets	Inspected
Benches	
Instance on Corner of Mill and Henry Streets	Inspected
Condition	2 - Between Good and Fair
Deficiency	No deficiencies recorded
Fence	
Instance on Corner of Mill and Henry Streets	Inspected
Condition	2 - Between Good and Fair
Deficiency	No deficiencies recorded
Pavement	
Instance on Corner of Mill and Henry Streets	Inspected
Condition	2 - Between Good and Fair
Deficiency	No deficiencies recorded
Play Equipment	
Instance on Corner of Mill and Henry Streets	Inspected
Condition	2 - Between Good and Fair
Deficiency	No deficiencies recorded
Safety Surfacing	
Instance on Corner of Mill and Henry Streets	Inspected
Condition	2 - Between Good and Fair
Deficiency	DETERIORATED/MISSING
Deficiency Location/Instance	Near Play Equipment

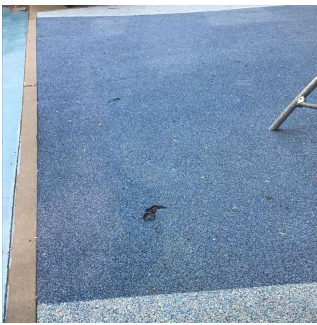
Deficiency Quantity	15
Quantity Uom	S.F.
Potential Action	REPLACE
Urgency of Action	PRIORITY 3
Purpose of Action	LEVEL 2

Question	Response
SITE	
PLAYGROUNDS	
Safety Surfacing	
Deficiency Photo1

Violations	Near Play Equipment No violations recorded.
Unpaved Area	
Instance on Corner of Mill and Henry Streets	Inspected
Condition	2 - Between Good and Fair
Deficiency	No deficiencies recorded
PLAYING SURFACE	Does not Exist
RETAINING WALLS	Does not Exist
SEATING	Inspected
Benches	Inspected
Concrete	Does not Exist
Metal/Wood/Plastic	Inspected
Condition	2 - Between Good and Fair
Deficiency	No deficiencies recorded
Bleachers	Does not Exist
SITE WALLS (NOT RETAINING WALLS)	Inspected
Condition	2 - Between Good and Fair
Deficiency	No deficiencies recorded
STAIRS/RAMPS: EXTERIOR	Does not Exist
