**NYC Department of Education
Building Condition Assessment Survey 2017 - 2018**

Architectural Inspection

M391

Asset: PRE-K CENTER@ 2-26 WASHINGTON ST-MANHATTAN, 2-26 WASHINGTON STREET, New York, 10004

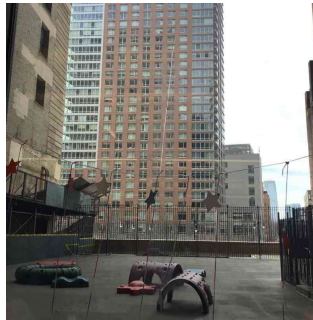
Question	Response
Architectural	
EXTERIOR	Inspected
AREAWAY	Does not Exist
AWNINGS AND CANOPIES	Does not Exist
CHIMNEY	Not Required
COPING	Not Required
CORNICE	Does not Exist
DOORS	Inspected
DOORS AND FRAMES	Inspected
Condition	2 - Between Good and Fair
Deficiency	No deficiencies recorded
DOOR HARDWARE	Inspected
Condition	2 - Between Good and Fair
Deficiency	No deficiencies recorded
LINTELS	Inspected
Condition	1 - Good
Deficiency	No deficiencies recorded
TRANSOM/SIDE LIGHT	Inspected
Condition	1 - Good
Deficiency	No deficiencies recorded
EXTERIOR WALLS	Inspected
Material Type(s)	Steel
Replacement Quantity	1,400
Replacement Uom	S.F.
Instance on All Facades	Inspected
Instance Condition	3 - Fair
Instance Quantity	1,400
Instance Quantity Uom	S.F.
Deficiency	METAL/GLASS CURT WALL: BROKEN GLASS

40
S.F.
REPLACE
PRIORITY 5
LEVEL 2

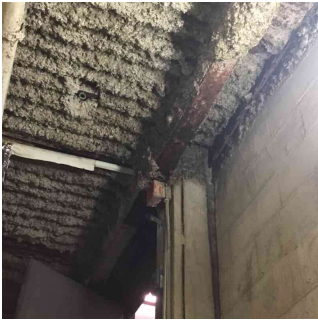
Question	Response
EXTERIOR	Inspected
WINDOWS	
WINDOWS	
Urgency of Action	PRIORITY 1
Purpose of Action	LEVEL 2
Deficiency Photo1	No photo recorded
Violations	No violations recorded.
INTERIOR	Inspected
POOLS	Does not Exist
STRUCTURAL	Inspected
COLUMNS/BEAMS/BEARING WALLS	Inspected
Condition	3 - Fair
Deficiency	STEEL COLUMNS/BEAMS: DETERIORATED/MISSING SPRAY-ON FIREPROOFING
Deficiency Location/Instance	Pump Room
Deficiency Quantity	50
Quantity Uom	S.F.
Potential Action	REPLACE
Urgency of Action	PRIORITY 4
Purpose of Action	LEVEL 5
Deficiency Photo1

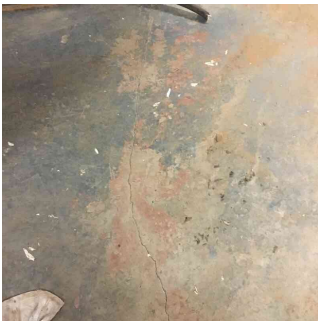
Violations	Pump Room No violations recorded.
FLOOR STRUCTURE	Inspected
Condition	4 - Between Fair and Poor
Deficiency	CONCRETE SLAB ON GRADE: MINOR CRACKS
Deficiency Location/Instance	Pump Room
Deficiency Quantity	30
Quantity Uom	S.F.
Potential Action	REPAIR
Urgency of Action	PRIORITY 3
Purpose of Action	LEVEL 5
Deficiency Photo1

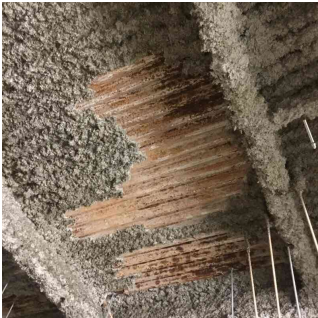
Question	Response
INTERIOR	Inspected
STRUCTURAL	
FLOOR STRUCTURE	
Violations	No violations recorded.
Deficiency	METAL DECK AND CONCRETE: DETERIORATED
Deficiency Location/Instance	Pump Room
Deficiency Quantity	150
Quantity Uom	S.F.
Potential Action	REPAIR
Urgency of Action	PRIORITY 4
Purpose of Action	LEVEL 5
Deficiency Photo1
