**NYC Department of Education
Building Condition Assessment Survey 2017 - 2018**

Architectural Inspection

M807

Asset: HARVEY MILK SCHOOL - MANHATTAN, 2-10 ASTOR PLACE, New York, 10003

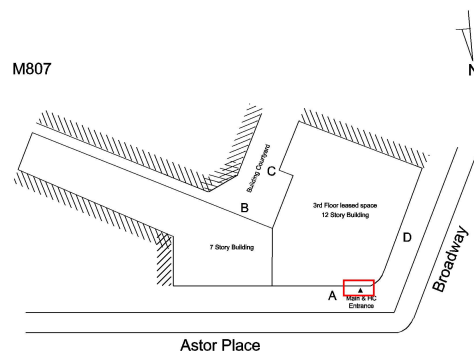
Question	Response
Architectural	
EXTERIOR	Inspected
AREAWAY	Not Required
AWNINGS AND CANOPIES	Does not Exist
CHIMNEY	Not Required
COPING	Not Required
CORNICE	Inspected
Condition	2 - Between Good and Fair
Deficiency	No deficiencies recorded
DOORS	Inspected
DOORS AND FRAMES	Inspected
Condition	3 - Fair
Deficiency	METAL: DETERIORATED DOOR AND FRAME - MAJOR DETERIORATION
Roof Plan reference

Deficiency Quantity	2
Quantity Uom	EACH
Potential Action	REPLACE
Urgency of Action	PRIORITY 4
Purpose of Action	LEVEL 2
Deficiency Photo1	No photo recorded
Violations	No violations recorded.
DOOR HARDWARE	Inspected
Condition	2 - Between Good and Fair
Deficiency	No deficiencies recorded
LINTELS	Inspected
Condition	2 - Between Good and Fair
Deficiency	No deficiencies recorded
TRANSOM/SIDE LIGHT	Inspected
Condition	2 - Between Good and Fair
Deficiency	No deficiencies recorded
EXTERIOR WALLS	Inspected
Material Type(s)	Masonry
Replacement Quantity	3,000

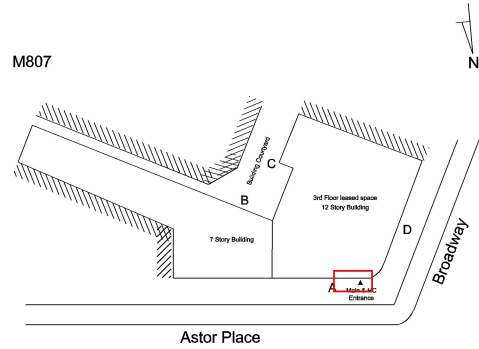
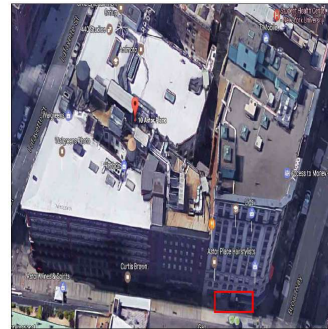
Replacement Uom	S.F.
Instance on All Facades	Inspected
Instance Condition	2 - Between Good and Fair
Instance Quantity	3,000
Instance Quantity Uom	S.F.
Deficiency	STUCCO CEMENT SURFACE: CRACKS, SPALLING

20
S.F.
REPLACE
PRIORITY 3
LEVEL 2
No photo recorded
No violations recorded.

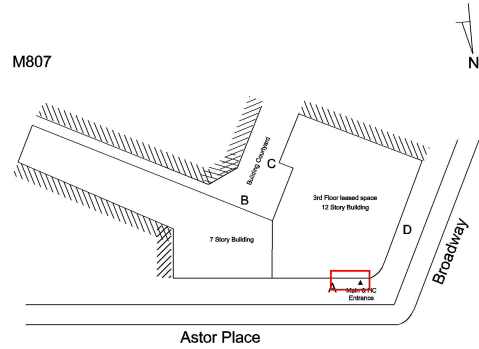
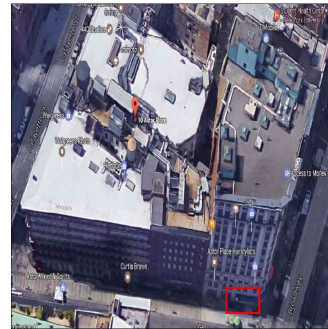
STONE: CHIPPED/SPALLED/BROKEN PIECES

20
S.F.

Question	Response
EXTERIOR	
EXTERIOR WALLS	
Potential Action	REPAIR
Urgency of Action	PRIORITY 3
Purpose of Action	LEVEL 2
Deficiency Photo1	No photo recorded
Violations	No violations recorded.
EXTERIOR SOFFITS	Does not Exist
LOADING DOCK	Does not Exist
LOUVER	Does not Exist
PARAPETS	Not Required
PLAZA DECK	Does not Exist
ROOF	Inspected
Roofing	Inspected
Replacement Uom	S.F.
ROOF HATCH/SMOKE HATCH	Not Required
LEADERS, GUTTERS, DOWNSPOUTS, SCUPPERS	Not Required
ROOF BARRIER	Does not Exist
ROOF CAGE	Does not Exist
ROOF FENCE	Does not Exist
ROOFING	Not Required
ROOFING DRAINS	Not Required
Specialties	Inspected
BULKHEAD/PENTHOUSE	Not Required
CUPOLA/ SPIRES/ TOWERS	Does not Exist
DORMER	Does not Exist
DUNNAGE STEEL	Not Required
SKYLIGHT/ROOF VENT	Not Required
ROOF/GRAVITY TANK	Not Required
STAIRS/RAMPS: EXTERIOR	Does not Exist
WINDOWS	Inspected
Replacement Quantity	1,300
Replacement Uom	S.F.
EXTERIOR GUARDS	Does not Exist
LINTELS	Inspected
