**NYC Department of Education
Building Condition Assessment Survey 2017 - 2018**

Architectural Inspection

M808

Asset: C.S.E. 3 (REGION 10) - MANHATTAN, 133 MORNINGSID AVENUE, New York, 10027

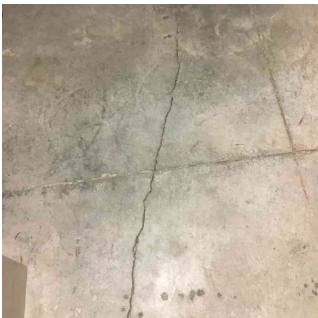
Basement - Record Storage Room
Violations	No violations recorded.
FOUNDATION WALLS	Inspected
Material Type(s)	Concrete
Condition	2 - Between Good and Fair
Deficiency	No deficiencies recorded
ROOF STRUCTURE	Inspected
Condition	2 - Between Good and Fair
Deficiency	No deficiencies recorded

Question	Response
EXTERIOR	
WINDOWS	
WINDOWS	
Instance Quantity	3,000
Instance Quantity Uom	S.F.
Installation Year	2004
Source of Installation	Custodial Staff
Deficiency	No deficiencies recorded
INTERIOR	Inspected
POOLS	Does not Exist
STRUCTURAL	Inspected
COLUMNS/BEAMS/BEARING WALLS	Inspected
Condition	2 - Between Good and Fair
Deficiency	No deficiencies recorded
FLOOR STRUCTURE	Inspected
Condition	3 - Fair
Deficiency	CONCRETE SLAB ON GRADE: THRU CRACKS
Deficiency Location/Instance	Basement - Record Storage Room
Deficiency Quantity	80
Quantity Uom	S.F.
Potential Action	REPAIR
Urgency of Action	PRIORITY 3
Purpose of Action	LEVEL 5
Deficiency Photo1

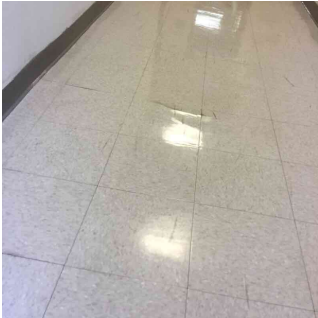
Question	Response
INTERIOR	
CLASSROOMS/CORRIDORS/ADMIN SPACES	
Door(s)	Inspected
Condition	2 - Between Good and Fair
Deficiency	No deficiencies recorded
Floor Finish	Inspected
Condition	2 - Between Good and Fair
Deficiency	VINYL TILES: BROKEN/DETERIORATED/MISSING TILES
Deficiency Location/Instance	Corridor near Room 613, 620, 622, 712, 814 and others
Deficiency Quantity	80
Quantity Uom	S.F.
Potential Action	REPLACE
Urgency of Action	PRIORITY 3
Purpose of Action	LEVEL 2
Deficiency Photo1
