**NYC Department of Education  
Building Condition Assessment Survey 2018 - 2019**

Architectural Inspection

Q383

**Asset:**        **PRE-K CENTER @ 132-10 JAMAICA AVENUE - QUEENS, 132-10 JAMAICA AVENUE,  
New York, 11418**

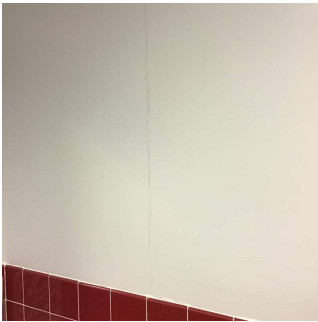
Question	Response
<b>INTERIOR</b>	
<b>TOILET ROOMS - STUDENTS</b>	
<b>Floor Finish</b>	Inspected
Condition	1 - Good
Deficiency	No deficiencies recorded
<b>Stalls</b>	Does not Exist
<b>Walls</b>	Inspected
Condition	2 - Between Good and Fair
Deficiency	GYPSUM BOARD: DETERIORATED
Deficiency Location/Instance	Room 114A
Deficiency Quantity	10
Quantity Uom	S.F.
Potential Action	REPLACE
Urgency of Action	PRIORITY 3
Purpose of Action	LEVEL 2
Deficiency Photo1
