**NYC Department of Education
Building Condition Assessment Survey 2017 - 2018**

Architectural Inspection

Q392

Asset: **PRE-K CENTER @ 68-20 MYRTLE AVENUE - QUEENS, 68-20 MYRTLE AVENUE, New York, 11385**

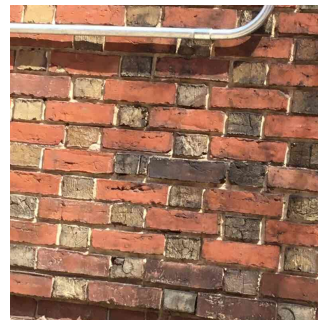
Facade E

Question	Response
Architectural	
EXTERIOR	Inspected
AREAWAY	Does not Exist
AWNINGS AND CANOPIES	Does not Exist
CHIMNEY	Does not Exist
COPING	Inspected
Condition	2 - Between Good and Fair
Deficiency	No deficiencies recorded
CORNICE	Does not Exist
DOORS	Inspected
DOORS AND FRAMES	Inspected
Condition	2 - Between Good and Fair
Deficiency	No deficiencies recorded
DOOR HARDWARE	Inspected
Condition	3 - Fair
Deficiency	No deficiencies recorded
LINTELS	Inspected
Condition	2 - Between Good and Fair
Deficiency	No deficiencies recorded
TRANSOM/SIDE LIGHT	Does not Exist
EXTERIOR WALLS	Inspected
Material Type(s)	Masonry
Replacement Quantity	9,210
Replacement Uom	S.F.
Instance on All Facades	Inspected
Instance Condition	3 - Fair
Instance Quantity	9,210
Instance Quantity Uom	S.F.
Deficiency	BRICK: OPEN JOINTS

250

REPOINT

PRIORITY 3

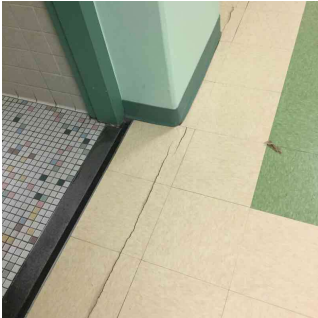
Corridor near Room 104
Violations	No violations recorded.
Walls	Inspected
Condition	1 - Good
Deficiency	No deficiencies recorded
Specialties	Does not Exist
GYMNASIUM	Does not Exist
INTERIOR DOOR HARDWARE	Inspected
Condition	2 - Between Good and Fair

Question	Response
INTERIOR	
STRUCTURAL	Inspected
ROOF STRUCTURE	Inspected
Condition	2 - Between Good and Fair
Deficiency	No deficiencies recorded
VAULTS-BUNKERS	Does not Exist
AUDITORIUM	Does not Exist
CAFETERIA	Does not Exist
CLASSROOMS/CORRIDORS/ADMIN SPACES	Inspected
Ceiling	Inspected
Condition	1 - Good
Deficiency	No deficiencies recorded
Door(s)	Inspected
Condition	1 - Good
Deficiency	No deficiencies recorded
Floor Finish	Inspected
Condition	2 - Between Good and Fair
Deficiency	VINYL TILES: DETERIORATED SUBSTRATE
Deficiency Location/Instance	Corridor near Rooms 104
Deficiency Quantity	10
Quantity Uom	S.F.
Potential Action	REPLACE
Urgency of Action	PRIORITY 3
Purpose of Action	LEVEL 2
Deficiency Photo1

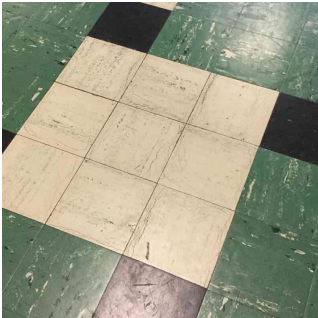
Near the center
Violations	No violations recorded.

Question	Response
INTERIOR	
KITCHEN	
Door(s)	
Instance on 1st Floor	Inspected
Condition	1 - Good
Deficiency	No deficiencies recorded
Floor Finish	
Instance on 1st Floor	Inspected
Condition	1 - Good
Deficiency	No deficiencies recorded
Walls	
Instance on 1st Floor	Inspected
Condition	1 - Good
Deficiency	No deficiencies recorded
LIBRARY	Does not Exist
LOCKER ROOM	Does not Exist
MULTI-PURPOSE ROOM	Inspected
Instance on Basement (1,000 SF)	Inspected
Ceiling	
Instance on Basement (1,000 SF)	Inspected
Condition	1 - Good
Deficiency	No deficiencies recorded
Door(s)	
Instance on Basement (1,000 SF)	Inspected
Condition	1 - Good
Deficiency	No deficiencies recorded
Fixed Equipment	
Instance on Basement (1,000 SF)	Does not Exist
Floor Finish	
Instance on Basement (1,000 SF)	Inspected
Condition	5 - Poor
Deficiency	VINYL TILES: DETERIORATED SUBSTRATE
Deficiency Location/Instance	Near the center, rear, side
Deficiency Quantity	400
Quantity Uom	S.F.

Potential Action	REPLACE
Urgency of Action	PRIORITY 3
Purpose of Action	LEVEL 2
Deficiency Photo1

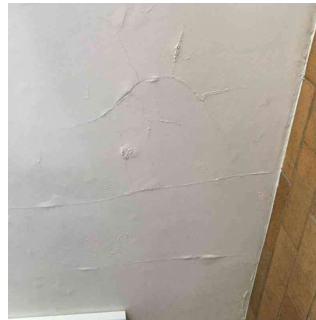
Condition	2 - Between Good and Fair
Deficiency	PLASTER: CRACKS/SPALLING
Deficiency Location/Instance	Room 209
Deficiency Quantity	15
Quantity Uom	S.F.
Potential Action	REPLACE
Urgency of Action	PRIORITY 3
Purpose of Action	LEVEL 2
Deficiency Photo1

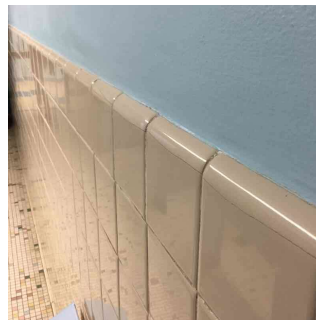
Room 204

Condition	2 - Between Good and Fair
Deficiency	CERAMIC TILE: BROKEN/ MISSING
Deficiency Location/Instance	Rooms 104, 204
Deficiency Quantity	30
Quantity Uom	S.F.
Potential Action	REPLACE
Urgency of Action	PRIORITY 3
Purpose of Action	LEVEL 2
Deficiency Photo1
