**NYC Department of Education
Building Condition Assessment Survey 2018 - 2019**

Architectural Inspection

Q414

Asset: PRE-K CENTER @ 106-02 NORTHERN BOULEVARD - QUEENS, 106-02 NORTHERN BOULEVARD, New York, 11368

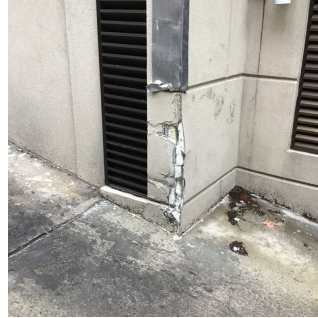
Facade K

STUCCO CEMENT SURFACE: CRACKS, SPALLING

30

REPLACE
PRIORITY 4
LEVEL 2

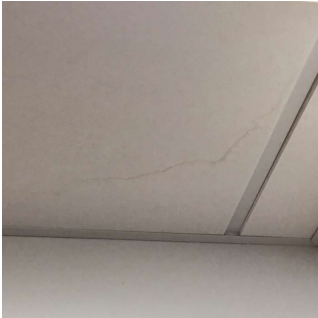
STUCCO CEMENT SURFACE: WATER INFILTRATION IN NON-INSTRUCTIONAL SPACE

50
S.F.
REPAIR
PRIORITY 5
LEVEL 2

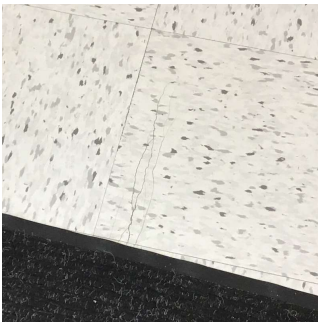
Question	Response
INTERIOR	
STRUCTURAL	
FLOOR STRUCTURE	Inspected
Condition	2 - Between Good and Fair
Deficiency	No deficiencies recorded
FOUNDATION WALLS	Inspected
Material Type(s)	Concrete
Condition	2 - Between Good and Fair
Deficiency	No deficiencies recorded
ROOF STRUCTURE	Inspected
Condition	2 - Between Good and Fair
Deficiency	No deficiencies recorded
VAULTS-BUNKERS	Does not Exist
AUDITORIUM	Does not Exist
CAFETERIA	Does not Exist
CLASSROOMS/CORRIDORS/ADMIN SPACES	Inspected
Ceiling	Inspected
Condition	1 - Good
Deficiency	No deficiencies recorded
Door(s)	Inspected
Condition	1 - Good
Deficiency	No deficiencies recorded
Floor Finish	Inspected
Condition	2 - Between Good and Fair
Deficiency	VINYL TILES: BROKEN/DETERIORATED/MISSING TILES
Deficiency Location/Instance	Main Entrance Lobby
Deficiency Quantity	10
Quantity Uom	S.F.
Potential Action	REPLACE
Urgency of Action	PRIORITY 3
Purpose of Action	LEVEL 2
Deficiency Photo1
