**NYC Department of Education
Building Condition Assessment Survey 2018 - 2019**

Architectural Inspection

Q437

Asset: **PRE-K CENTER @ 98-22 55 AVENUE - QUEENS, 98-22 55 AVENUE, New York, 11368**

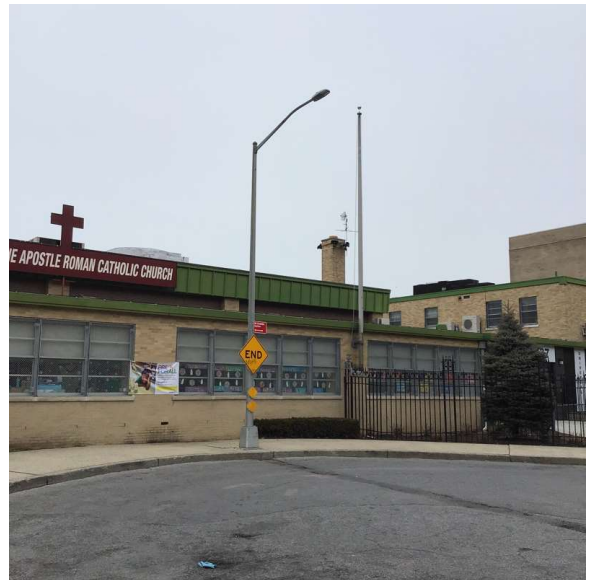
98th Place - Northeast view

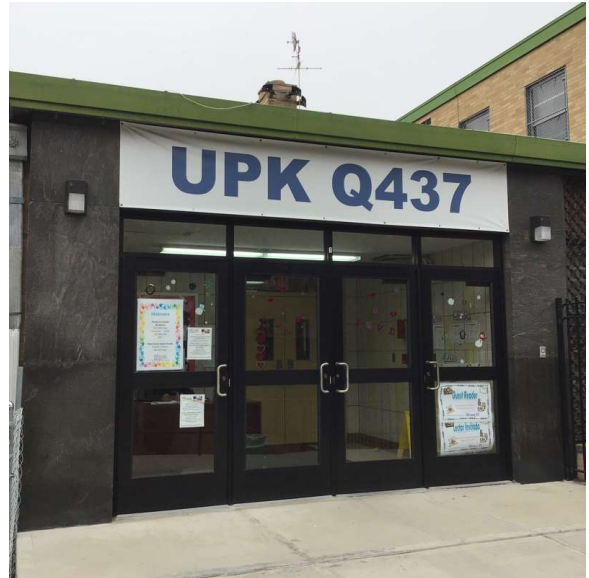
Facade A - 98th Place

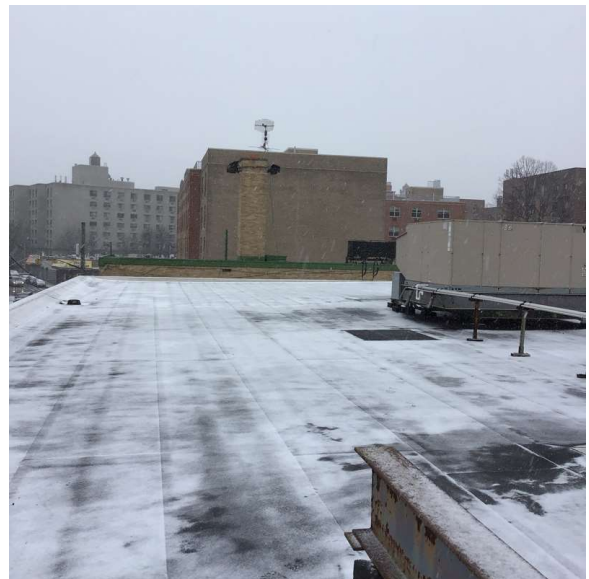
Roof 2 - East view

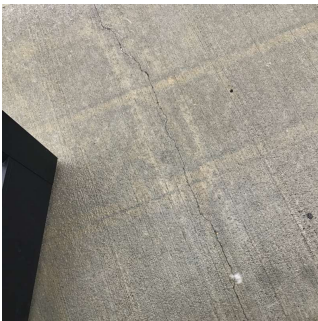
Violations	Near Main Entrance No violations recorded.
Pavers	Does not Exist
DOT Sidewalk	Does not Exist
PLAYGROUNDS	Does not Exist
PLAYING SURFACE	Does not Exist
RETAINING WALLS	Does not Exist
SEATING	Does not Exist

Question	Response
INTERIOR	Inspected
TOILET ROOMS - STUDENTS	Inspected
Walls	
Deficiency	No deficiencies recorded
LIFE SAFETY	Inspected
F.D. HOLDING AREA	Does not Exist
STEEL STAIRS	Does not Exist
SITE	Inspected
CONTAINERIZATION	Does not Exist
Drainage System for Asphalt	Does not Exist
Drainage System for Concrete	Does not Exist
Drainage System for Soil	Does not Exist
DRINKING FOUNTAINS	Does not Exist
FENCES	Inspected
Condition	2 - Between Good and Fair
Deficiency	No deficiencies recorded
IRRIGATION SYSTEM	Does not Exist
PAVING	Inspected
Student Non-Use	Does not Exist
Student Use	Does not Exist
Site Sidewalks & Walkways	Inspected
Asphalt	Does not Exist
Concrete	Inspected
Condition	2 - Between Good and Fair
Deficiency	DAMAGED/DETERIORATED/MISSING SECTIONS
Deficiency Location/Instance	Near Main Entrance
Deficiency Quantity	25
Quantity Uom	S.F.
Potential Action	REPLACE
Urgency of Action	PRIORITY 3
Purpose of Action	LEVEL 2
