**NYC Department of Education  
Building Condition Assessment Survey 2017 - 2018**

Architectural Inspection

**Asset:** P.S. 41 TRANSPORTABLE - Q, 214-43 35 AVENUE, New York, 11361

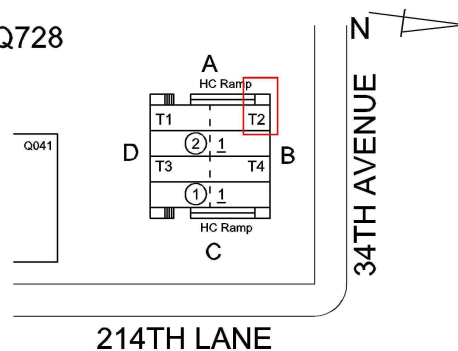
Question	Response
<b>Architectural</b>	
<b>EXTERIOR</b>	Inspected
<b>AWNINGS AND CANOPIES</b>	Does not Exist
<b>DOORS</b>	Inspected
<b>DOORS AND FRAMES</b>	Inspected
Condition	2 - Between Good and Fair
Deficiency	No deficiencies recorded
<b>DOOR HARDWARE</b>	Inspected
Condition	3 - Fair
Deficiency	No deficiencies recorded
<b>EXTERIOR WALLS</b>	Inspected
Material Type(s)	Steel
Replacement Quantity	2,600
Replacement Uom	S.F.
Instance on All Facades	Inspected
Instance Condition	3 - Fair
Instance Quantity	2,600
Instance Quantity Uom	S.F.
Deficiency	METAL PANEL: MAJOR RUSTING
Roof Plan reference

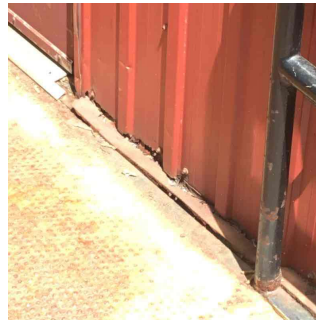
Facade A

Deficiency Quantity

25

Potential Action

REPLACE

Urgency of Action

PRIORITY 4

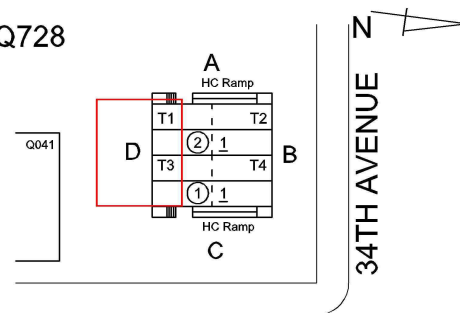
Roof Plan reference

METAL PANEL: DAMAGED TRIM

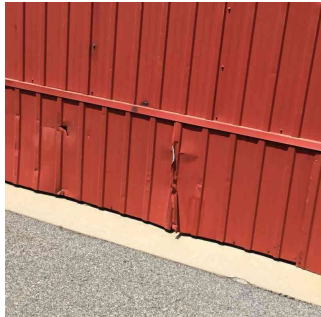
Deficiency Quantity

50

L.F.

Potential Action

REPLACE

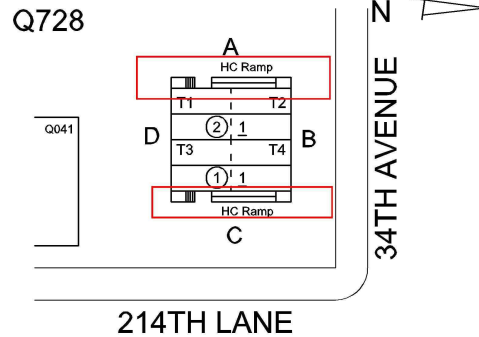
Roof Plan reference

Deficiency	No deficiencies recorded
<b>STAIRS/RAMPS</b>	Inspected
Condition	3 - Fair
Deficiency	METAL: RUST - MINOR

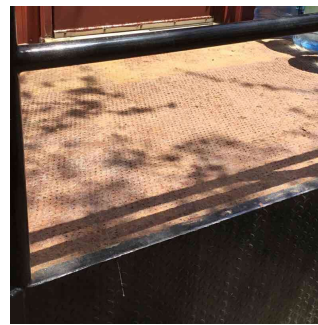
Facade A  
No violations recorded.

Deficiency Quantity  
Quantity Uom  
Potential Action  
Urgency of Action  
Purpose of Action  
Deficiency Photo1

30  
S.F.  
REPAINT  
PRIORITY 3  
LEVEL 2

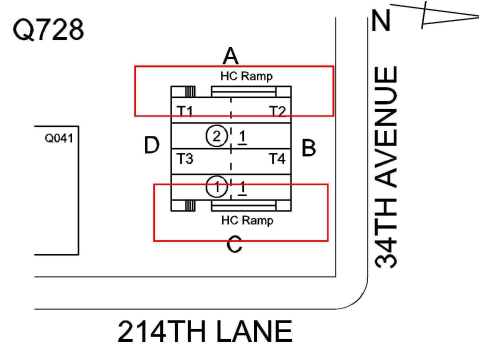
Roof Plan reference

RUST - MINOR

Deficiency Quantity	50
Quantity Uom	S.F.
Potential Action	MAINTENANCE
Urgency of Action	PRIORITY 3
Purpose of Action	LEVEL 2
Deficiency Photo1	No photo recorded
Violations	No violations recorded.
<b>WINDOWS</b>	Inspected
Material Type(s)	Aluminum
Instance on Aluminum - Other: Facade A and C	Inspected
Instance Condition	3 - Fair
Instance Quantity	128
Instance Quantity Uom	S.F.
Installation Year	2001
Source of Installation	Custodial Staff
Deficiency	No deficiencies recorded
<b>INTERIOR</b>	Inspected
<b>STRUCTURAL</b>	Inspected
<b>COLUMNS/BEAMS/BEARING WALLS</b>	Inspected
Condition	2 - Between Good and Fair
Deficiency	No deficiencies recorded
<b>FLOOR STRUCTURE</b>	Inspected
Condition	2 - Between Good and Fair
Deficiency	No deficiencies recorded
<b>ROOF STRUCTURE</b>	Inspected
Condition	2 - Between Good and Fair
Deficiency	No deficiencies recorded
