**NYC Department of Education
Building Condition Assessment Survey 2017 - 2018**

Architectural Inspection

Q891

Asset: R. F. WAGNER SEC SCL ARTS & TECH-Q, 47-07 30TH PLACE, New York, 11101

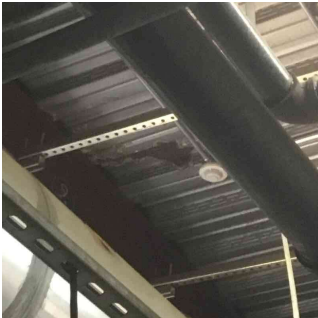
Instance Condition	1 - Good
Instance Quantity	2,000
Instance Quantity Uom	S.F.
Installation Year	2015
Source of Installation	Custodial Staff
Deficiency	No deficiencies recorded
INTERIOR	Inspected
POOLS	Does not Exist
STRUCTURAL	Inspected
COLUMNS/BEAMS/BEARING WALLS	Inspected
Condition	2 - Between Good and Fair
Deficiency	No deficiencies recorded
FLOOR STRUCTURE	Inspected
Condition	3 - Fair
Deficiency	METAL DECK AND CONCRETE: DETERIORATED
Deficiency Location/Instance	Boiler Room

Question	Response
INTERIOR	
STRUCTURAL	
FLOOR STRUCTURE	
Deficiency Quantity	10
Quantity Uom	S.F.
Potential Action	REPAIR
Urgency of Action	PRIORITY 3
Purpose of Action	LEVEL 5
Deficiency Photo1

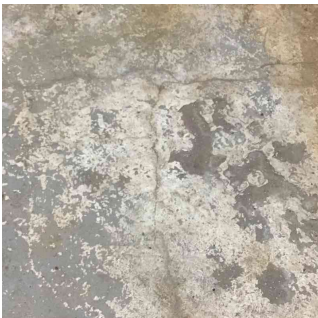
Violations	Boiler Room No violations recorded.
Deficiency	CONCRETE SLAB ON GRADE: MINOR CRACKS
Deficiency Location/Instance	Electric Panel Room
Deficiency Quantity	50
Quantity Uom	S.F.
Potential Action	REPAIR
Urgency of Action	PRIORITY 3
Purpose of Action	LEVEL 5
Deficiency Photo1

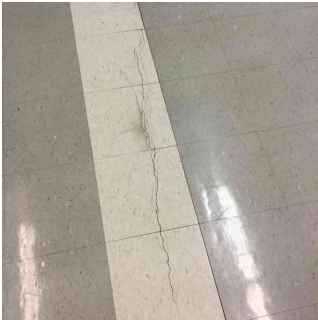
Question	Response
INTERIOR	
CAFETERIA	Inspected
Window Curtains/Shades/Blinds	
Instance on 1st Floor - Staff (500 SF)	Does not Exist
CLASSROOMS/CORRIDORS/ADMIN SPACES	Inspected
Ceiling	Inspected
Condition	2 - Between Good and Fair
Deficiency	No deficiencies recorded
Door(s)	Inspected
Condition	2 - Between Good and Fair
Deficiency	No deficiencies recorded
Floor Finish	Inspected
Condition	2 - Between Good and Fair
Deficiency	VINYL TILES: DETERIORATED SUBSTRATE
Deficiency Location/Instance	Corridor near Rooms 121, 215, 249, by 2nd Floor Girls Toilet, Stair H/1, and others
Deficiency Quantity	50
Quantity Uom	S.F.
Potential Action	REPLACE
Urgency of Action	PRIORITY 3
Purpose of Action	LEVEL 2
Deficiency Photo1

Corridor near Stair H/1	
Violations	No violations recorded.
Walls	Inspected
Condition	2 - Between Good and Fair
Deficiency	GLASS BLOCK: DAMAGED/MISSING
Deficiency Location/Instance	Corridor near Room 206 (main office), by 2nd Floor main corridor stair, near the Library

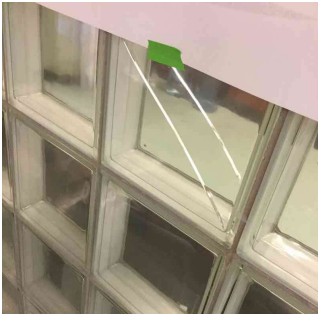
Deficiency Quantity	20
Quantity Uom	S.F.
Potential Action	REPLACE
Urgency of Action	PRIORITY 3
Purpose of Action	LEVEL 2
Deficiency Photo1

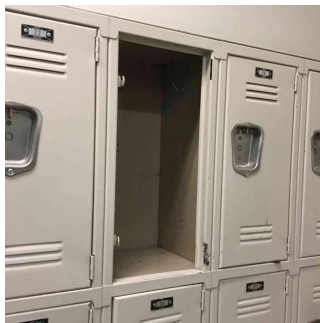
Deficiency	No deficiencies recorded
Instance on 2nd Floor - Girls (75 Lockers)	Inspected
Condition	2 - Between Good and Fair
Deficiency	No deficiencies recorded
Locker Room Lockers	
Instance on 2nd Floor - Boys (75 Lockers)	Inspected
Condition	2 - Between Good and Fair
Deficiency	DAMAGED UNITS
Deficiency Location/Instance	Near locker 22
Deficiency Quantity	1
Quantity Uom	EACH
Potential Action	REPLACE
Urgency of Action	PRIORITY 3
Purpose of Action	LEVEL 2

Question	Response
INTERIOR	
LOCKER ROOM	
Locker Room Lockers	
Deficiency Photo1

Violations	Near locker 22 No violations recorded.
Walls	
Instance on 2nd Floor - Boys (75 Lockers)	Inspected
Condition	2 - Between Good and Fair
Deficiency	No deficiencies recorded
Instance on 2nd Floor - Girls (75 Lockers)	Inspected
Condition	2 - Between Good and Fair
Deficiency	No deficiencies recorded
MULTI-PURPOSE ROOM	Does not Exist
SCIENCE DEMO ROOM	Does not Exist
SCIENCE LAB	Inspected
Instance on Rooms 233, 235	Inspected
Alternative use	No
Fixed Equipment	
Instance on Rooms 233, 235	Inspected
Condition	2 - Between Good and Fair
Deficiency	No deficiencies recorded
SCIENCE PREP ROOM	Inspected
Instance on Room 234	Inspected
Alternative use	No
Fixed Equipment	
Instance on Room 234	Inspected
Condition	2 - Between Good and Fair
Deficiency	CABINETRY: MISSING/DAMAGED
Deficiency Location/Instance	Room 234
Deficiency Quantity	2
Quantity Uom	L.F.

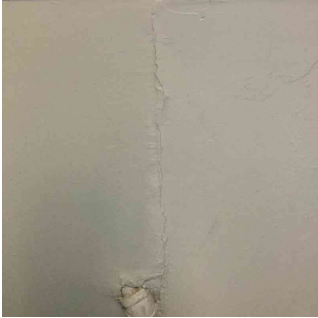
Question	Response
INTERIOR	
SHOWER ROOM	
Walls	
Deficiency Photo1	 
Violations	Near the entrance No violations recorded.
STAIRS/RAMPS: INTERIOR	
Do Letter Stair Signs Exist?	Inspected Yes
Ceiling	Does not Exist
Door(s)	Inspected
Condition	5 - Poor
Deficiency	METAL CLAD WOOD: DETERIORATED DOOR
Deficiency Location/Instance	Stars D/2, E/2
Deficiency Quantity	2
Quantity Uom	EACH
Potential Action	MAINTENANCE
Urgency of Action	PRIORITY 3
Purpose of Action	LEVEL 2
Deficiency Photo1	 
Violations	Stair E/2 No violations recorded.
Partition	Does not Exist
Railings	Inspected
Condition	2 - Between Good and Fair
Deficiency	No deficiencies recorded
Stairs and Landings	Inspected
Condition	2 - Between Good and Fair
Deficiency	No deficiencies recorded
Walls	Inspected
Condition	2 - Between Good and Fair
Deficiency	GYPSUM BOARD: DETERIORATED
Deficiency Location/Instance	Stair H/2
Deficiency Quantity	10
Quantity Uom	S.F.

Question	Response
INTERIOR	
STAIRS/RAMPS: INTERIOR	
Walls	
Potential Action	REPLACE
Urgency of Action	PRIORITY 3
Purpose of Action	LEVEL 2
Deficiency Photo1

Stair H/2
Violations	No violations recorded.
TOILET ROOMS - STAFF	Inspected
Ceiling	Inspected
Condition	2 - Between Good and Fair
Deficiency	No deficiencies recorded
Door(s)	Inspected
Condition	2 - Between Good and Fair
Deficiency	No deficiencies recorded
Floor Finish	Inspected
Condition	2 - Between Good and Fair
Deficiency	No deficiencies recorded
Stalls	Inspected
Condition	2 - Between Good and Fair
Deficiency	No deficiencies recorded
Walls	Inspected
Condition	2 - Between Good and Fair
Deficiency	No deficiencies recorded
TOILET ROOMS - STUDENTS	Inspected
Ceiling	Inspected
Condition	2 - Between Good and Fair
Deficiency	No deficiencies recorded
Door(s)	Inspected
Condition	2 - Between Good and Fair
Deficiency	No deficiencies recorded
Floor Finish	Inspected
Condition	2 - Between Good and Fair

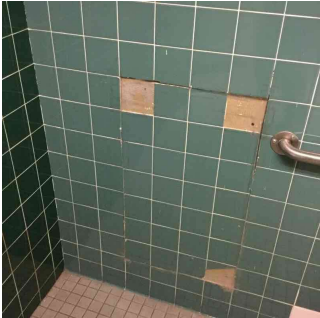
Deficiency	No deficiencies recorded
Stalls	Inspected
Condition	2 - Between Good and Fair
Deficiency	No deficiencies recorded
Walls	Inspected
Condition	2 - Between Good and Fair
Deficiency	CERAMIC TILE: BROKEN/ MISSING
Deficiency Location/Instance	1st Floor Boys, Girls

Question	Response
INTERIOR	
TOILET ROOMS - STUDENTS	
Walls	
Deficiency Quantity	10
Quantity Uom	S.F.
Potential Action	REPLACE
Urgency of Action	PRIORITY 3
Purpose of Action	LEVEL 2
Deficiency Photo1

Violations	1st Floor Boys No violations recorded.
LIFE SAFETY	Inspected
F.D. HOLDING AREA	Does not Exist
STEEL STAIRS	Does not Exist
SITE	Inspected
CONTAINERIZATION	Does not Exist
Drainage System for Asphalt	Does not Exist
Drainage System for Concrete	Does not Exist
Drainage System for Soil	Does not Exist
DRINKING FOUNTAINS	Does not Exist
FENCES	Does not Exist
IRRIGATION SYSTEM	Does not Exist
PAVING	Inspected
Student Non-Use	Does not Exist
Student Use	Does not Exist
Site Sidewalks & Walkways	Does not Exist
DOT Sidewalk	Inspected
Asphalt	Does not Exist
Concrete	Inspected
Condition	3 - Fair
Deficiency	DAMAGED/DETERIORATED/MISSING SECTIONS
Deficiency Location/Instance	48th Avenue
Deficiency Quantity	50
Quantity Uom	S.F.
Potential Action	REPLACE

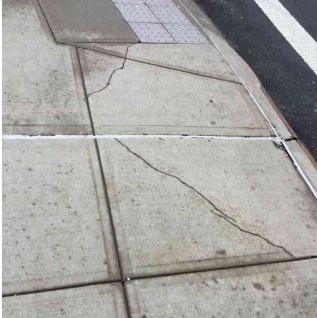
Question	Response
SITE	
PAVING	
DOT Sidewalk	
Concrete	
Deficiency Photo1

Violations	48th Avenue No violations recorded.
Pavers	Inspected
Condition	2 - Between Good and Fair
Deficiency	No deficiencies recorded
PLAYGROUNDS	Does not Exist
PLAYING SURFACE	Does not Exist
RETAINING WALLS	Does not Exist
SEATING	Does not Exist
SITE WALLS (NOT RETAINING WALLS)	Does not Exist
STAIRS/RAMPS: EXTERIOR	Does not Exist
