NYC Department of Education
Building Condition Assessment Survey 2020 - 2021

Architectural Inspection

Asset: P.S. 16 TRANSPORTABLE - Q, 41-15 104 STREET, New York, 11368

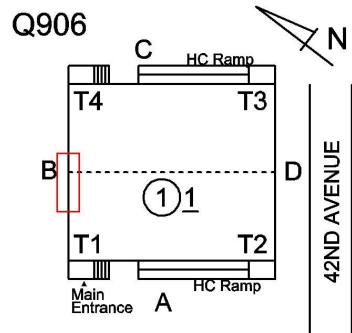
Question	Response
Architectural	
EXTERIOR	Inspected
AWNINGS AND CANOPIES	Does not Exist
DOORS	Inspected
DOORS AND FRAMES	Inspected
Condition	1 - Good
Deficiency	No deficiencies recorded
DOOR HARDWARE	Inspected
Condition	1 - Good
Deficiency	No deficiencies recorded
EXTERIOR WALLS	Inspected
Material Type(s)	Steel
Replacement Quantity	2,600
Replacement Uom	S.F.
Instance on All Facades	Inspected
Instance Condition	3 - Fair
Instance Quantity	2,600
Instance Quantity Uom	S.F.
Deficiency	METAL PANEL: DAMAGED TRIM
Roof Plan reference

Question	Response
EXTERIOR	
EXTERIOR WALLS	
Elevation	 
Deficiency Quantity	10
Quantity Uom	L.F.
Potential Action	REPLACE
Urgency of Action	PRIORITY 4
Purpose of Action	LEVEL 2
Deficiency Photo1	 
Violations	Facade B No violations recorded.
EXTERIOR SOFFITS	Does not Exist
LOUVER	Inspected
Condition	1 - Good
Deficiency	No deficiencies recorded
ROOF	Inspected
Roofing	Inspected
Replacement Quantity	2,600
Replacement Uom	S.F.
LEADERS, GUTTERS, DOWNSPOUTS, SCUPPERS	Does not Exist
ROOFING	Inspected
Instance on Single Ply, Fully Adhered Roof: Roof 1	Inspected
Instance Condition	2 - Between Good and Fair
Instance Quantity	2,600
Instance Quantity Uom	S.F.
Does the roof have major mechanical equipment sitting on Dunnage Steel less than 18" above the Roofing?	No
Installation Year	2015
Source of Installation	Custodial Staff
Deficiency	No deficiencies recorded
STAIRS/RAMPS: EXTERIOR	Inspected
RAILINGS	Inspected
Condition	5 - Poor

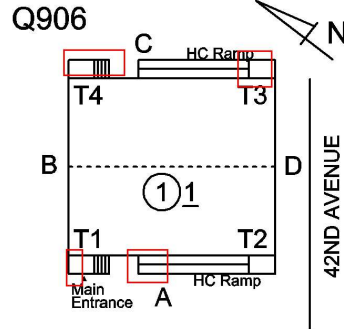
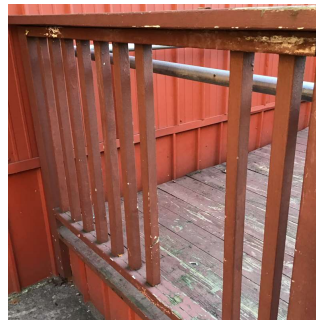
Priority Condition Exist Last Year?	Priority Category	Condition Description	Component Affected	Location Description	Person(s) Notified	Person(s) Title	PhotoImage
No	Damaged/Deteriorated Railings	Missing railing is a potential safety hazard.	EXTERIOR STAIRS/RAMP S: EXTERIOR RAILINGS	North and South Ramps and Stairs.	Stephen Schillizzi	Fireman

MISSING RAILING

40
 L.F.
 REPLACE
 PRIORITY 5
 LEVEL 6

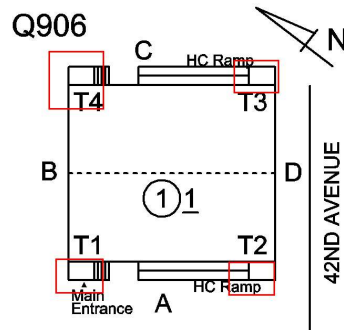
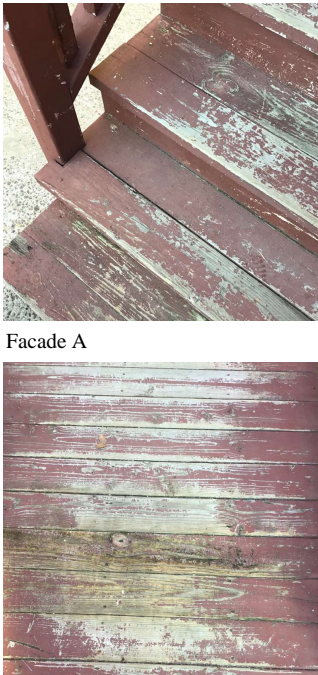
Inspected
 5 - Poor
 WOOD: DETERIORATED

100
 S.F.
 REPLACE
 PRIORITY 4
 LEVEL 2

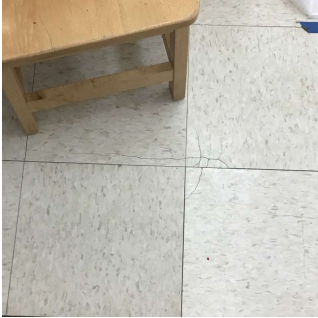
Question	Response
INTERIOR	
CAFETERIA	Does not Exist
CLASSROOMS/CORRIDORS/ADMIN SPACES	Inspected
Ceiling	Inspected
Condition	1 - Good
Deficiency	No deficiencies recorded
Door(s)	Inspected
Condition	1 - Good
Deficiency	No deficiencies recorded
Floor Finish	Inspected
Condition	2 - Between Good and Fair
Deficiency	VINYL TILES: BROKEN/DETERIORATED/MISSING TILES
Deficiency Location/Instance	T1, 2, 3, 4
Deficiency Quantity	45
Quantity Uom	S.F.
Potential Action	REPLACE
Urgency of Action	PRIORITY 3
Purpose of Action	LEVEL 2
Deficiency Photo1
