**NYC Department of Education**  
**Building Condition Assessment Survey 2017 - 2018**

Architectural Inspection

**Asset: PRE-K CENTER @120 STUYVESANT PLACE - STATEN ISLAND, 120 STUYVESANT PLACE, New York, 10301**

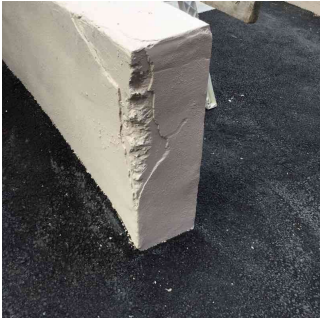
Question	Response
<b>SITE</b>	
<b>RETAINING WALLS</b>	
Deficiency Photo1

Condition	2 - Between Good and Fair
Deficiency	CAST IN PLACE CONCRETE: CRACKS/SPALLING - MAJOR
Deficiency Location/Instance	Teacher parking lot
Deficiency Quantity	10
Quantity Uom	S.F.
Potential Action	REPLACE
Urgency of Action	PRIORITY 3
Purpose of Action	LEVEL 2

Violations	Teacher parking lot No violations recorded.
<b>SEATING</b>	Does not Exist
<b>SITE WALLS (NOT RETAINING WALLS)</b>	Does not Exist
<b>STAIRS/RAMPS: EXTERIOR</b>	Does not Exist
