**NYC Department of Education
Building Condition Assessment Survey 2017 - 2018**

Architectural Inspection

Asset: **PRE-K CENTER @ 3560 WEBSTER AVENUE - BRONX, 3560 WEBSTER AVENUE, New York, 10467**

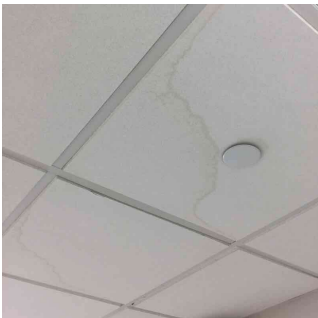
Question	Response
INTERIOR	
STRUCTURAL	
FLOOR STRUCTURE	Inspected
Violations	No violations recorded.
FOUNDATION WALLS	Not Required
ROOF STRUCTURE	Inspected
Condition	2 - Between Good and Fair
Deficiency	No deficiencies recorded
VAULTS-BUNKERS	Does not Exist
AUDITORIUM	Does not Exist
CAFETERIA	Does not Exist
CLASSROOMS/CORRIDORS/ADMIN SPACES	Inspected
Ceiling	Inspected
Condition	2 - Between Good and Fair
Deficiency	ACOUSTIC TILES: DAMAGED/MISSING
Deficiency Location/Instance	Corridor near Room 107
Deficiency Quantity	10
Quantity Uom	S.F.
Potential Action	REPLACE
Urgency of Action	PRIORITY 3
Purpose of Action	LEVEL 2
Deficiency Photo1

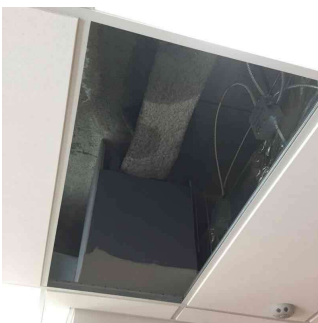
Violations	Room 113

Violations	Corridor near Room 107 No violations recorded.
Deficiency	ACOUSTIC TILES: DAMAGED/MISSING - ACTIVE LEAK
Deficiency Location/Instance	Corridor near Exit to the Playground, Rooms 109, 113
Deficiency Quantity	30
Quantity Uom	S.F.
Potential Action	REPLACE
Urgency of Action	PRIORITY 5

Purpose of Action	LEVEL 2
Deficiency Photo1

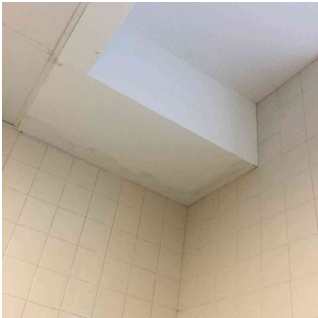
Near Windows
Violations	No violations recorded.
Door(s)	
Instance on Room 123	Inspected
Condition	1 - Good

Question	Response
INTERIOR	
CLASSROOMS/CORRIDORS/ADMIN SPACES	
Ceiling	Inspected
Violations	No violations recorded.
Door(s)	Inspected
Condition	1 - Good
Deficiency	No deficiencies recorded
Floor Finish	Inspected
Condition	1 - Good
Deficiency	No deficiencies recorded
Walls	Inspected
Condition	1 - Good
Deficiency	No deficiencies recorded
Specialties	Does not Exist
GYMNASIUM	Does not Exist
INTERIOR DOOR HARDWARE	Inspected
Condition	1 - Good
Deficiency	No deficiencies recorded
INTERIOR GUARDS	Does not Exist
KITCHEN	Inspected
Instance on Room 123	Inspected
Ceiling	
Instance on Room 123	Inspected
Condition	2 - Between Good and Fair
Deficiency	GYPSUM BOARD: DAMAGED/DETERIORATED
Deficiency Location/Instance	Near Windows
Deficiency Quantity	20
Quantity Uom	S.F.
Potential Action	REPLACE
Urgency of Action	PRIORITY 3
Purpose of Action	LEVEL 2
