**NYC Department of Education
Building Condition Assessment Survey 2017 - 2018**

Architectural Inspection

X776

Asset: I.S. 045 ANNEX (PLAY YARD) - BRONX, 531 EAST 188TH STREET, New York, 10458

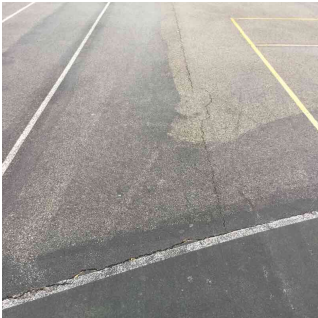
Question	Response
SITE	
PAVING	
Student Use	
Asphalt	
Quantity Uom	S.F.
Potential Action	REPLACE
Urgency of Action	PRIORITY 3
Purpose of Action	LEVEL 2
Deficiency Photo1

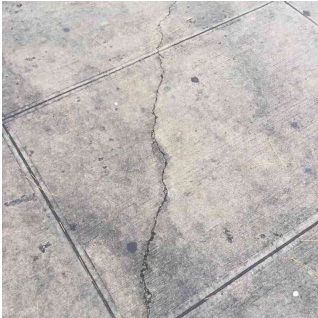
Lorillard Avenue
Violations	No violations recorded.
Concrete	Inspected
Condition	2 - Between Good and Fair
Deficiency	No deficiencies recorded
Pavers	Inspected
Condition	2 - Between Good and Fair
Deficiency	No deficiencies recorded
Site Sidewalks & Walkways	Does not Exist
DOT Sidewalk	Inspected
Asphalt	Does not Exist
Concrete	Inspected
Condition	4 - Between Fair and Poor
Deficiency	DAMAGED/DETERIORATED/MISSING SECTIONS
Deficiency Location/Instance	East 189th Street, East 188th Street, Lorillard Avenue, Bathgate Avenue
Deficiency Quantity	900
Quantity Uom	S.F.
Potential Action	REPLACE
Urgency of Action	PRIORITY 3
Purpose of Action	LEVEL 2
Deficiency Photo1

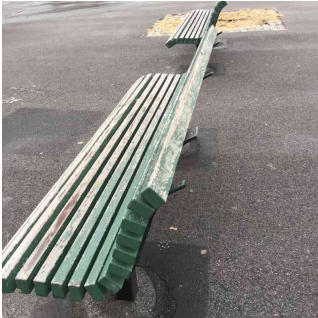
Priority Condition Exist Last Year?	Priority Category	Condition Description	Component Affected	Location Description	Person(s) Notified	Person(s) Title	PhotoImage
No	Protruding Elements	Damaged bench with protruding metal is a Potential Safety Hazard	SITE SEATING Benches Metal/Wood/Plastic	North Side of Schoolyard	Daniel Manz	Cleaner

Unpaved Area	
Instance on North Side of Schoolyard	Does not Exist
PLAYING SURFACE	Does not Exist
RETAINING WALLS	Does not Exist
SEATING	Inspected
Benches	Inspected
Concrete	Does not Exist
Metal/Wood/Plastic	Inspected
Condition	3 - Fair
Deficiency	DAMAGED/DETERIORATED

Question	Response
SITE	
SEATING	
Benches	
Metal/Wood/Plastic	
Deficiency Location/Instance	North Side of Schoolyard
Deficiency Quantity	1
Quantity Uom	EACH
Potential Action	REPLACE
Urgency of Action	PRIORITY 5
Purpose of Action	LEVEL 6
Deficiency Photo1

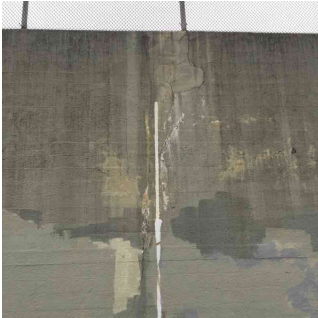
Violations	North Side of Schoolyard No violations recorded.
Bleachers	Does not Exist
SITE WALLS (NOT RETAINING WALLS)	Inspected
Condition	3 - Fair
Deficiency	CAST IN PLACE CONCRETE: CRACKS/SPALLING - MAJOR
Deficiency Location/Instance	South Side of Schoolyard
Deficiency Quantity	50
Quantity Uom	S.F.
Potential Action	REPLACE
Urgency of Action	PRIORITY 3
Purpose of Action	LEVEL 2
Deficiency Photo1
