**NYC Department of Education
Building Condition Assessment Survey 2017 - 2018**

Architectural Inspection

X945

Asset: P.S. 87 TRANSPORTABLE - X, 1935 BUSSING AVENUE, New York, 10466

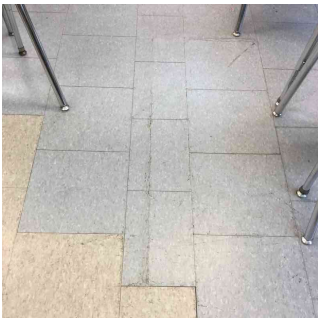
Question	Response
INTERIOR	
CLASSROOMS/CORRIDORS/ADMIN SPACES	
Door(s)	Inspected
Deficiency	No deficiencies recorded
Floor Finish	Inspected
Condition	3 - Fair
Deficiency	VINYL TILES: DETERIORATED SUBSTRATE
Deficiency Location/Instance	In T1,2,5,7,8, and others
Deficiency Quantity	250
Quantity Uom	S.F.
Potential Action	REPLACE
Urgency of Action	PRIORITY 3
Purpose of Action	LEVEL 2
Deficiency Photo1

Violations	In T2 No violations recorded.
Walls	Inspected
Condition	2 - Between Good and Fair
Deficiency	No deficiencies recorded
INTERIOR DOOR HARDWARE	
Condition	3 - Fair
Deficiency	No deficiencies recorded
KITCHEN	
	Does not Exist
MULTI-PURPOSE ROOM	
	Does not Exist
TOILET ROOMS - STAFF	
	Does not Exist
TOILET ROOMS - STUDENTS	
	Inspected
Ceiling	Inspected
Condition	2 - Between Good and Fair
Deficiency	No deficiencies recorded
Door(s)	Inspected
Condition	2 - Between Good and Fair
Deficiency	No deficiencies recorded
Floor Finish	Inspected
