NYC Department of Education
Building Condition Assessment Survey 2021 - 2022

Architectural Inspection

**Asset: PRE-K CENTER @ 80-55 CORNISH AVENUE - QUEENS, 80-55 CORNISH AVENUE,
 New York, 11373**

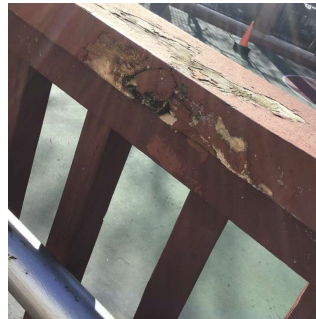
Facade B

Question	Response
EXTERIOR	
ROOF	
Roofing	
ROOFING	
Instance Quantity Uom	S.F.
Does the roof have major mechanical equipment sitting on Dunnage Steel less than 18" above the Roofing?	No
Installation Year	2016
Source of Installation	Custodial Staff
Deficiency	No deficiencies recorded
STAIRS/RAMPS: EXTERIOR	Inspected
RAILINGS	Inspected
Condition	4 - Between Fair and Poor
Deficiency	DAMAGED
Roof Plan reference

20
L.F.
REPLACE
PRIORITY 4
LEVEL 2

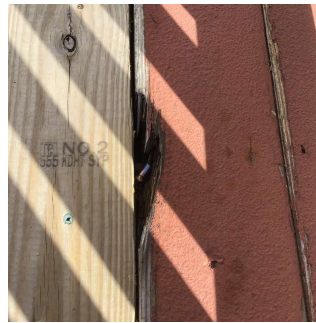
Facade B - T4

STAIRS/RAMPS	Inspected
Condition	3 - Fair
Deficiency	WOOD: DETERIORATED

10
S.F.
REPLACE
PRIORITY 4
LEVEL 2

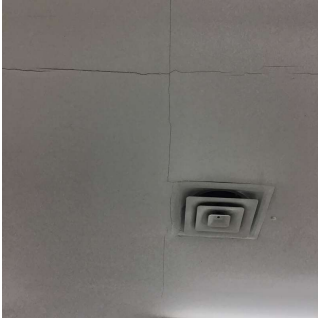
Question	Response
INTERIOR	
STRUCTURAL	
FLOOR STRUCTURE	Inspected
Condition	2 - Between Good and Fair
Deficiency	No deficiencies recorded
ROOF STRUCTURE	Inspected
Condition	2 - Between Good and Fair
Deficiency	No deficiencies recorded
CAFETERIA	Does not Exist
CLASSROOMS/CORRIDORS/ADMIN SPACES	Inspected
Ceiling	Inspected
Condition	2 - Between Good and Fair
Deficiency	GYPSUM BOARD: DAMAGED/DETERIORATED
Deficiency Location/Instance	Rooms T3,T4
Deficiency Quantity	30
Quantity Uom	S.F.
Potential Action	REPLACE
Urgency of Action	PRIORITY 3
Purpose of Action	LEVEL 2
Deficiency Photo1

Room T4
Violations	No violations recorded.
Door(s)	Inspected
Condition	2 - Between Good and Fair
Deficiency	No deficiencies recorded
Floor Finish	Inspected
Condition	2 - Between Good and Fair
Deficiency	VINYL TILES: DETERIORATED SUBSTRATE
Deficiency Location/Instance	Rooms T2,T3
Deficiency Quantity	25
Quantity Uom	S.F.
Potential Action	REPLACE
