**NYC Department of Education
Building Condition Assessment Survey 2017 - 2018**

Architectural Inspection

M391

Asset: PRE-K CENTER@ 2-26 WASHINGTON ST-MANHATTAN, 2-26 WASHINGTON STREET, New York, 10004

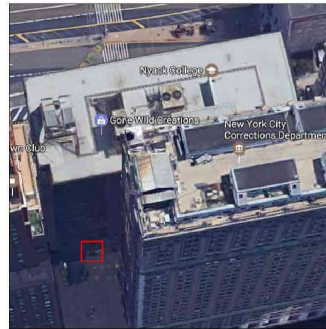
Elevation

Question	Response
Architectural	
EXTERIOR	Inspected
AREAWAY	Does not Exist
AWNINGS AND CANOPIES	Does not Exist
CHIMNEY	Not Required
COPING	Not Required
CORNICE	Does not Exist
DOORS	Inspected
DOORS AND FRAMES	Inspected
Condition	2 - Between Good and Fair
Deficiency	No deficiencies recorded
DOOR HARDWARE	Inspected
Condition	2 - Between Good and Fair
Deficiency	No deficiencies recorded
LINTELS	Inspected
Condition	1 - Good
Deficiency	No deficiencies recorded
TRANSOM/SIDE LIGHT	Inspected
Condition	1 - Good
Deficiency	No deficiencies recorded
EXTERIOR WALLS	Inspected
Material Type(s)	Steel
Replacement Quantity	1,400
Replacement Uom	S.F.
Instance on All Facades	Inspected
Instance Condition	3 - Fair
Instance Quantity	1,400
Instance Quantity Uom	S.F.
Deficiency	METAL/GLASS CURT WALL: BROKEN GLASS

40
S.F.
REPLACE
PRIORITY 5
LEVEL 2
