**NYC Department of Education
Building Condition Assessment Survey 2018 - 2019**

Architectural Inspection

Q437

Asset: **PRE-K CENTER @ 98-22 55 AVENUE - QUEENS, 98-22 55 AVENUE, New York, 11368**

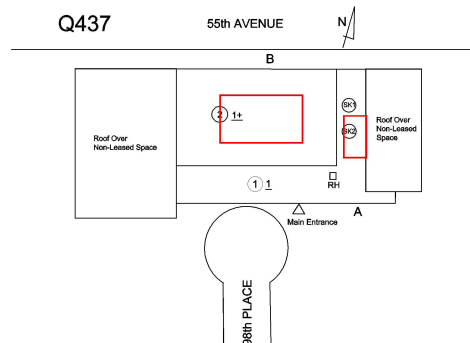
Deficiency	No deficiencies recorded
Specialties	Inspected
BULKHEAD/PENTHOUSE	Does not Exist
CUPOLA/ SPIRES/ TOWERS	Does not Exist
DORMER	Does not Exist
DUNNAGE STEEL	Inspected
Condition	3 - Fair
Deficiency	MINOR RUSTING
Roof Plan reference

Question	Response
EXTERIOR	
ROOF	
Specialties	
DUNNAGE STEEL	
Deficiency Quantity	100
Quantity Uom	L.F.
Potential Action	MAINTENANCE
Urgency of Action	PRIORITY 3
Purpose of Action	LEVEL 2
Deficiency Photo1	No photo recorded
Violations	No violations recorded.
Deficiency	HEIGHT LESS THAN 18"
Roof Plan reference	<p align="center">Q437 55th AVENUE N</p>
Deficiency Quantity	100
Quantity Uom	L.F.
Potential Action	REPLACE
Urgency of Action	PRIORITY 1
Purpose of Action	LEVEL 1
Deficiency Photo1	
Violations	Roof 1 No violations recorded.
SKYLIGHT/ROOF VENT	Inspected
Material Type(s)	Plastic
Condition	2 - Between Good and Fair
Deficiency	No deficiencies recorded
ROOF/GRAVITY TANK	Does not Exist
STAIRS/RAMPS: EXTERIOR	Does not Exist
WINDOWS	Inspected
Replacement Quantity	1,400
Replacement Uom	S.F.
EXTERIOR GUARDS	Inspected
Condition	2 - Between Good and Fair
Deficiency	No deficiencies recorded

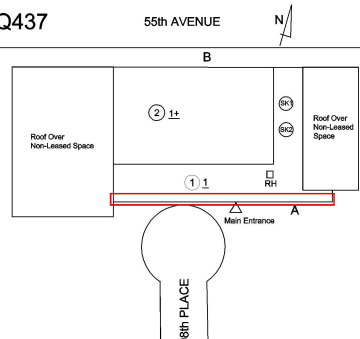
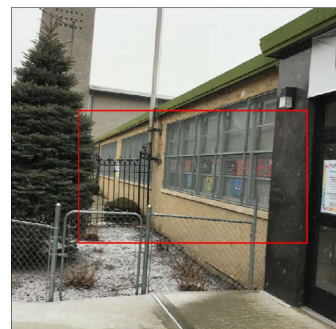
Elevation

Question	Response
EXTERIOR	
WINDOWS	
LINTELS	Inspected
Condition	2 - Between Good and Fair
Deficiency	No deficiencies recorded
WINDOWS	Inspected
Material Type(s)	Aluminum
Instance on Aluminum - Double Hung: Facade A	Inspected
Instance Condition	3 - Fair
Instance Quantity	600
Instance Quantity Uom	S.F.
Installation Year	1968
Source of Installation	Custodial Staff
Deficiency	ALUMINUM - DOUBLE HUNG: INOPERABLE BALANCE
Roof Plan reference	<p align="center">Q437 55th AVENUE N</p>

Deficiency Quantity	6
Quantity Uom	EACH
Potential Action	MAINTENANCE
Urgency of Action	PRIORITY 3
Purpose of Action	LEVEL 2
Deficiency Photo1	No photo recorded
Violations	No violations recorded.
Deficiency	ALUMINUM - DOUBLE HUNG: BEYOND USEFUL LIFE
Deficiency Location/Instance	Aluminum - Double Hung: Facade A
Deficiency Quantity	600
Quantity Uom	S.F.
Potential Action	REPLACE
Urgency of Action	PRIORITY 1
Purpose of Action	LEVEL 2
Deficiency Photo1	No photo recorded
