**NYC Department of Education
Building Condition Assessment Survey 2017 - 2018**

Architectural Inspection

Asset: **PRE-K CENTER @ 3560 WEBSTER AVENUE - BRONX, 3560 WEBSTER AVENUE, New York, 10467**

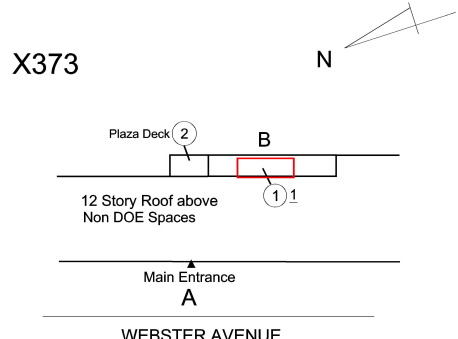
Question	Response
EXTERIOR	
ROOF	
Roofing	
ROOF CAGE	Does not Exist
ROOF FENCE	Inspected
Condition	2 - Between Good and Fair
Deficiency	No deficiencies recorded
ROOFING	Inspected
Instance on Single Ply, Fully Adhered Roof: Roof 1	Inspected
Instance Condition	2 - Between Good and Fair
Instance Quantity	12,000
Instance Quantity Uom	S.F.
Does the roof have major mechanical equipment sitting on Dunnage Steel less than 18" above the Roofing?	No
Installation Year	2016
Source of Installation	Custodial Staff
Deficiency	SINGLE PLY, FULLY ADHERED ROOF: ROOFING: MINOR LEAKAGE
Roof Plan reference

Deficiency Quantity	50
Quantity Uom	S.F.
Potential Action	REPAIR
Urgency of Action	PRIORITY 5
Purpose of Action	LEVEL 2
Deficiency Photo1
